**KANEPACKAGE PHILIPPINE INC.**

**INVESTIGATION REPORT FORM (IRF)**
☒ Inhouse Detection

Customer	SANYO DENKI	Attention To	Mr. Gerald De Guzman
Item Code	00939007-01	Department	PRODUCTION
Item Description	CORRUGATED CARTON	Date of Detection	21 03 24
Job Order Number	JO21-M-00203-17	Section Detected	QA - SCREENING

## INVESTIGATION REPORT FOR SMEARED PRINT OF SANYO DENKI 00939007-01 CORRUGATED CARTON

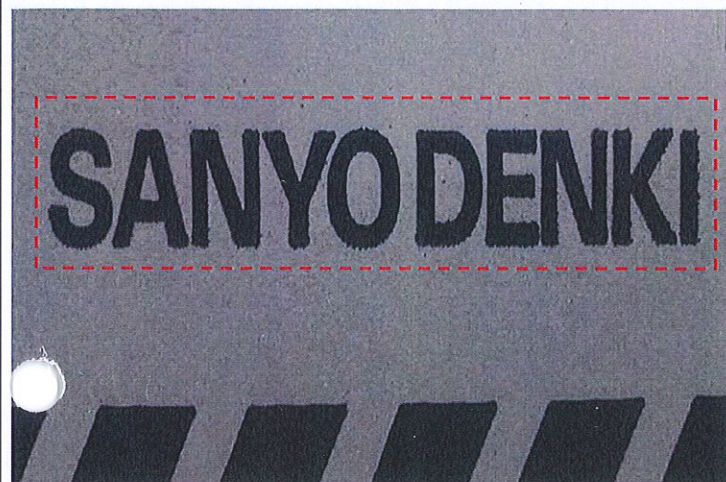
**ILLUSTRATION OF THE PROBLEM**

<input type="checkbox"/> Major <input checked="" type="checkbox"/> Minor		
Lot Quantity (pcs.)	Reject Quantity (pcs.)	Reject Percentage
2500	94	3.76%
Nature of Defect:		
SMEARED PRINT		
Requirement:		
No smear print		
Actual:		
W/ Smeared print on the logo

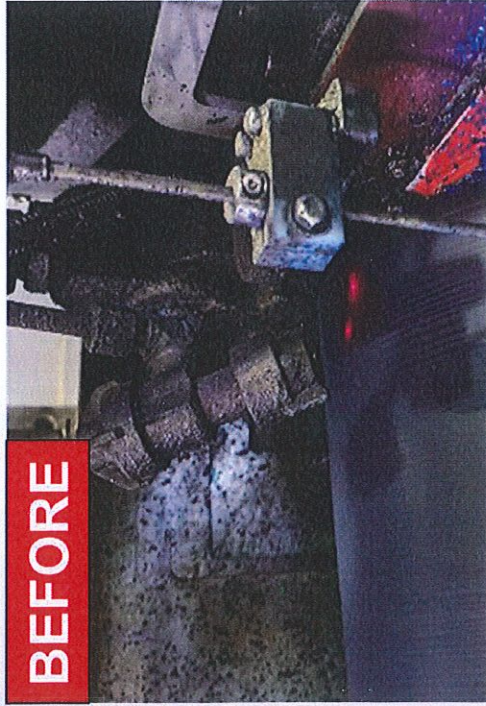
**BEFORE**

<b>DIRECT CAUSE PROCESS/MATERIAL</b>	W1- The uneven distribution of water in shower nozzle is the caused of smeared print.
	W2- Due to uneven distribution of water, the ink viscosity get high during mass production that caused smeared and blotted print.
	W3- Affected items processed last March 21, 2021, while the shower nozzle replaced March 24,2021.

**LEFT NOZZLE**

>The nozzles were replaced because they produced water with uneven volumes

Monitor this item next running since the shower nozzle are replaced last March 24, 2021			
PIC:	PRODUCTION	TARGET DATE:	210406

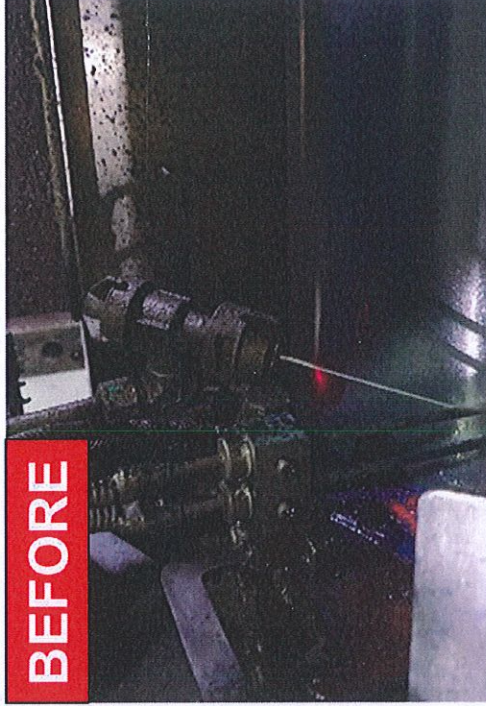
**BEFORE**

**RIGHT NOZZLE**
