**KANEPACKAGE PHILIPPINE INC.**

INVESTIGATION REPORT FORM (IRF)☐ Inhouse Detection☒ Customer Claim

Customer	SANYO DENKI	Attention To	Mr. Gerald De Guzman
Item Code	00958861-02	Department	PRODUCTION
Item Description	PAD	Date of Detection	21 04 14
Job Order Number	JO21-M-00423-12	Section Detected	CUSTOMER - SDP

INVESTIGATION REPORT FOR 00958861-02 BURSTING & SPLICE WASTE

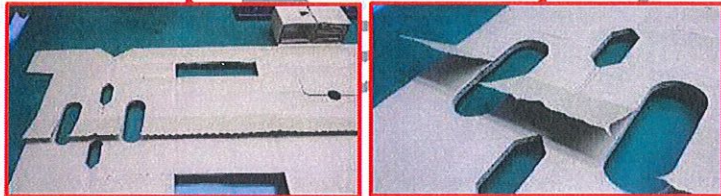
**EXCESS ON PAD**

BURSTING & SPLICE WASTE

SPLICE WASTE: Not Acceptable in any occurrence
BURSTING: Maximum of 50mm only

The item has splice waste on its surface and it also has a bursting >50mm

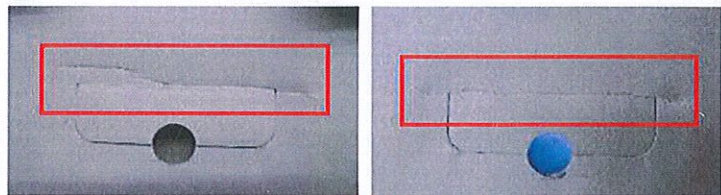
**TORN**

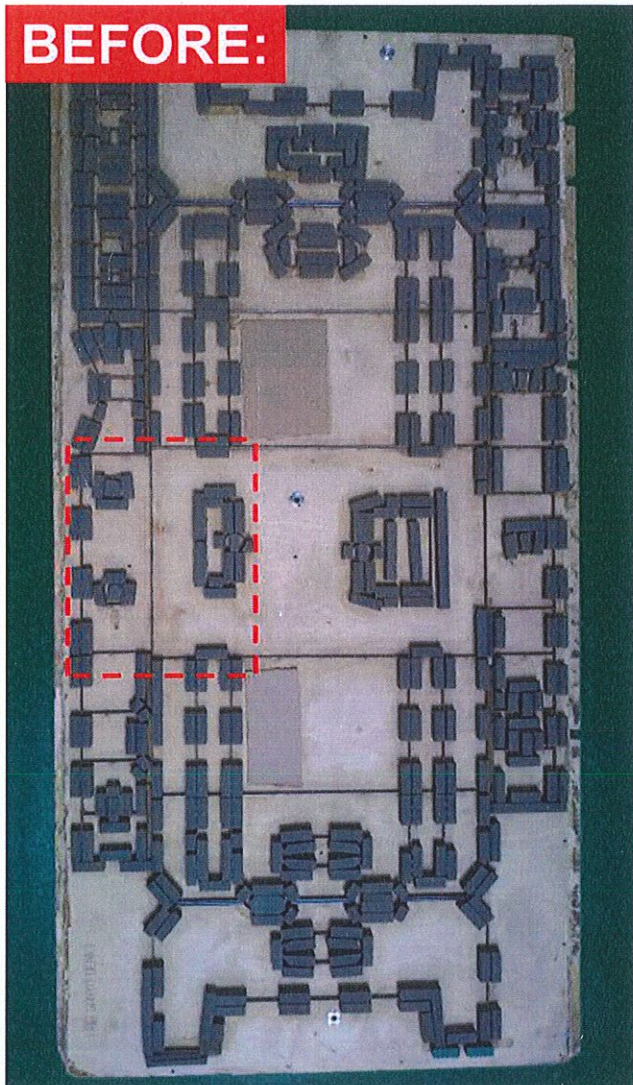
BEFORE:

> Brittle materials
> The ejector of the diecut blade is rubber sponge.

DIRECT CAUSE PROCESS/MATERIAL	W1- Diecut Blade used Rubber Sponge as an ejector in the creasing blade that may contribute to bursting
	W2-
	W3-

> For Diecut Blade, coordinated to Tooling Custodians to change the rubber sponge to eperan and to standardized to use eperan on the creasing blades instead of rubber sponge when bursting occurs.
