**KANEPACKAGE PHILIPPINE INC.**

INVESTIGATION REPORT FORM (IRF)☒ Inhouse Detection☐ Customer Claim

Item Description: CORRUGATED CARTON

INVESTIGATION REPORT FOR POOR PRINT OF SANYO DENKI 00918237-01 CORRUGATED CARTON

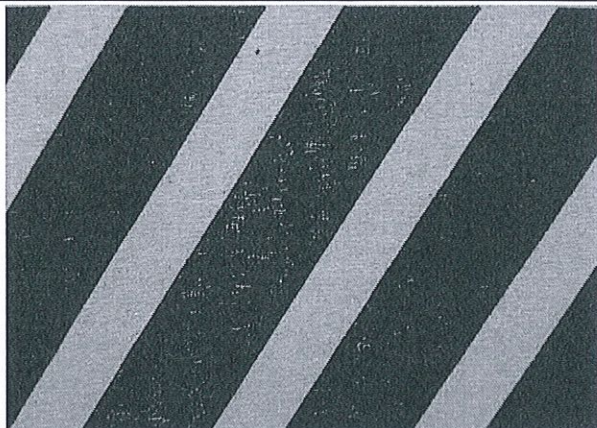
POOR PRINT

W/ POOR PRINT ON THE SOLID IMAGE

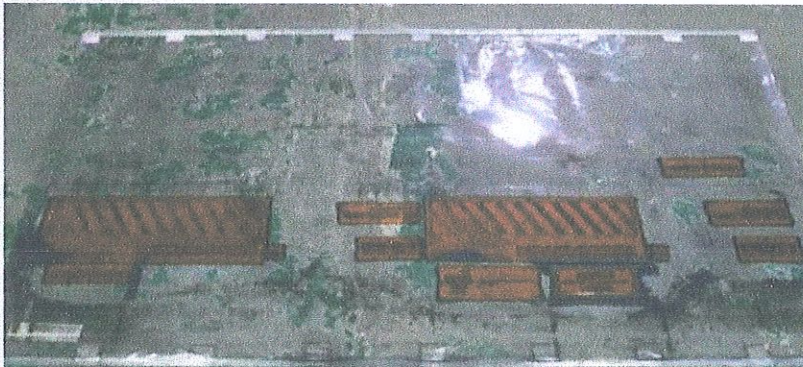
DIRECT CAUSE PROCESS/MATERIAL	W1- The texture of the surface of material is rough and the cyrel composed of hard cyrel.
	W2- Due to rough texture of material the hard cyrel did not penetrate well in the solid image print that caused poor print.

The flexoplate of the item is composed of Hard flexoplates

Since the rough texture of materials is inherent to UPPC according to QA our counter measure is the replacement of cyrel from Hard cyrel to combination of Hard & Soft cyrel, since on ME study the Soft cyrel is much better in solid image print.

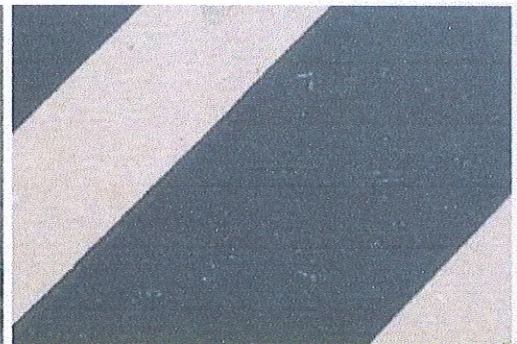
The materials' surface is rough.

Based on the actual condition of boards the surface of materials' kraftliner is rough

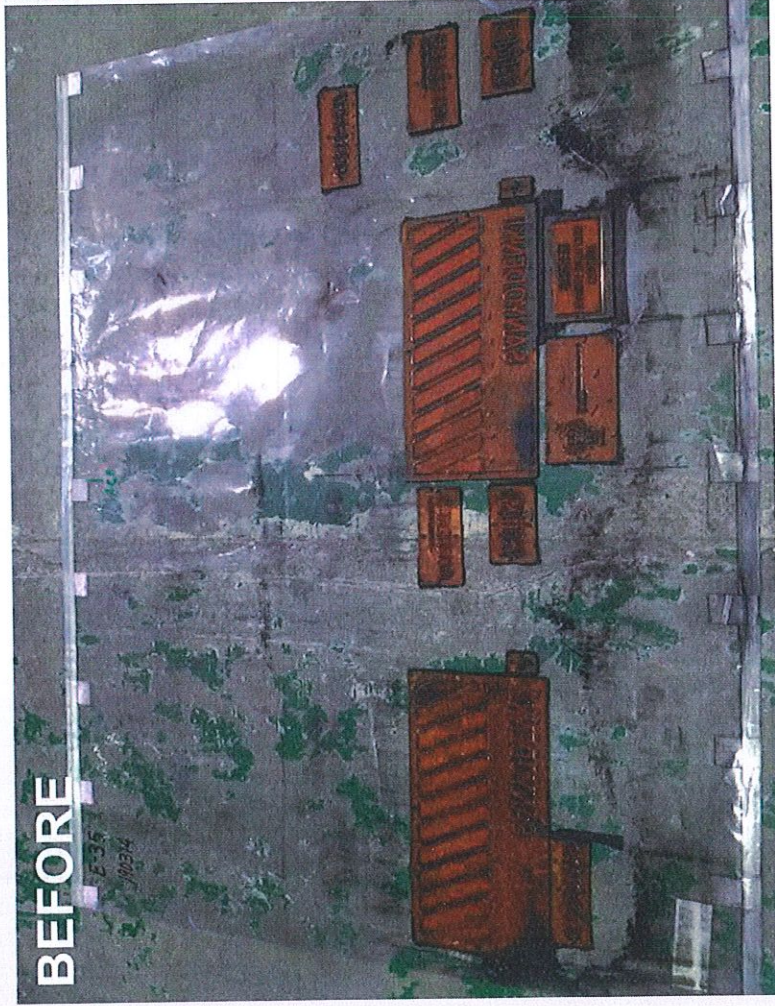
BEFORE

Old flexoplate was composed of hard plates

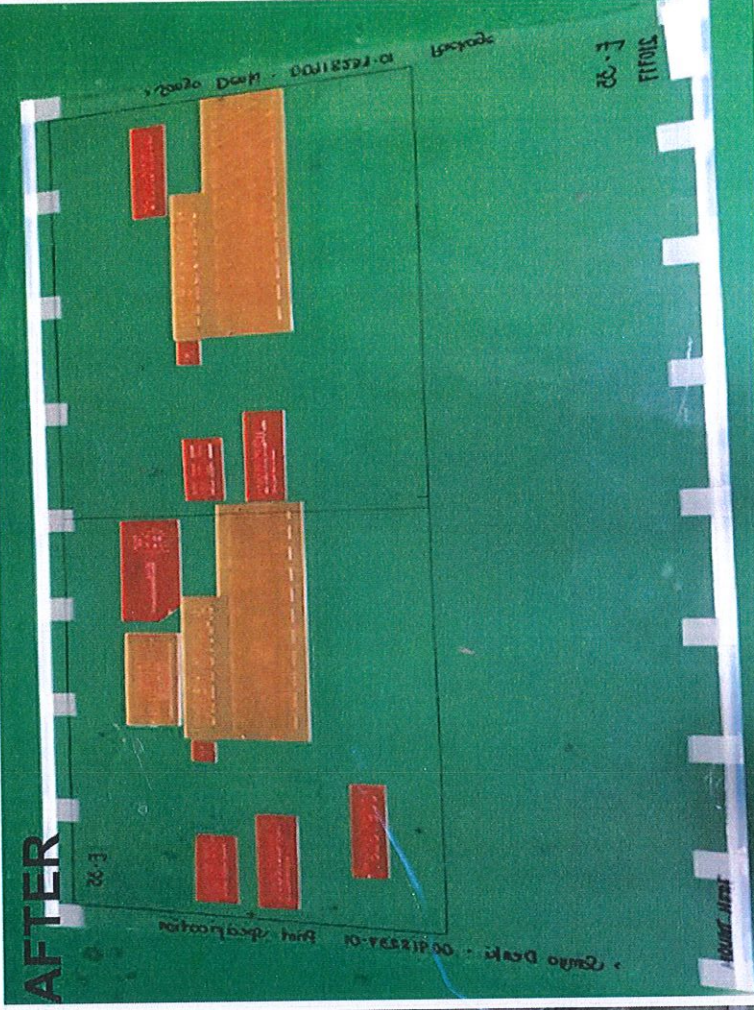
Solid layouts are soft flexoplates

REMARKS: New cyrel is for monitoring of effectiveness
