# KANEPACKAGE PHILIPPINE INC.

## INVESTIGATION REPORT FORM (IRF)

Customer	CANON	Attention To	Mr. Gerald De Guzman
Item Code	RX1-5781-000	Department	PRODUCTION
Item Description	Z10 CARTON	Date of Detection	21 06 10
Job Order Number	JO-F-21-191-1	Section Detected	QA - IN LINE

# INVESTIGATION REPORT FOR BURSTING OF CBMP RX1-5781-000

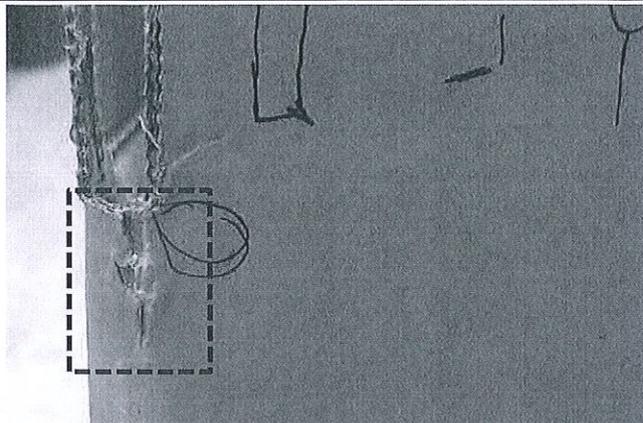
<input type="checkbox"/> Major <input checked="" type="checkbox"/> Minor		
Lot Quantity (pcs.)	Reject Quantity (pcs.)	Reject Percentage
2,600	170	6.54%
Nature of Defect:		
BURSTING		
Requirement:		
Bursting is not acceptable		
Actual:		
Bursting length is 15mm

Due to broken creasing matrix & over impression of die cut blade

>The creasing matrix is worn-out (also the steel plate  
 > Due to over impression of dieblade in the sheets

> Change to new plate and creasing matrix since the previous plate was used as common plate before when Eterna were lacking on steel plate.			
<b>PIC:</b>	Production	<b>TARGET DATE:</b>	210615
> Monitor the next running of this item and study the effect of the pressure used.			
<b>PIC:</b>	Production and ME	<b>TARGET DATE:</b>	210616
> Coordinate to ME regarding changing of rectangular slot to rounded slot.			
<b>PIC:</b>	Production and ME	<b>TARGET DATE:</b>	For Discussion
> Create Eterna Plate Condition Checksheet and will conduct weekly checking of Eterna Plate condition care of Production Leader-in-Charge.			
<b>PIC:</b>	Production	<b>TARGET DATE:</b>	210618

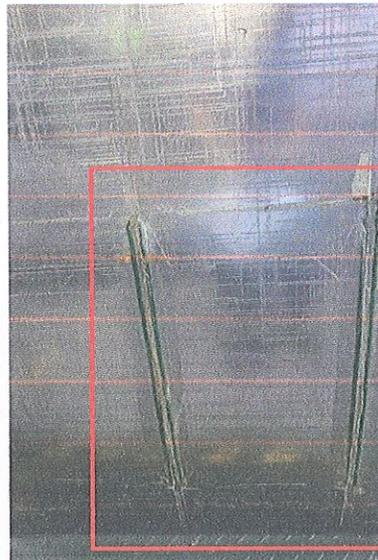
<b>DIRECT CAUSE PROCESS/MATERIAL</b>	W1- Due to uncut encountered in slot during mass production.	W1- Due to un-sticking of creasing matrix on plate.
	W2- Due to the blade used is not continuous or it is rectangular slot.	
	W3- Due to the applied pressure was 1.5 tons.

Operator put tape on the creasing matrix to avoid extra movement during diecutting.

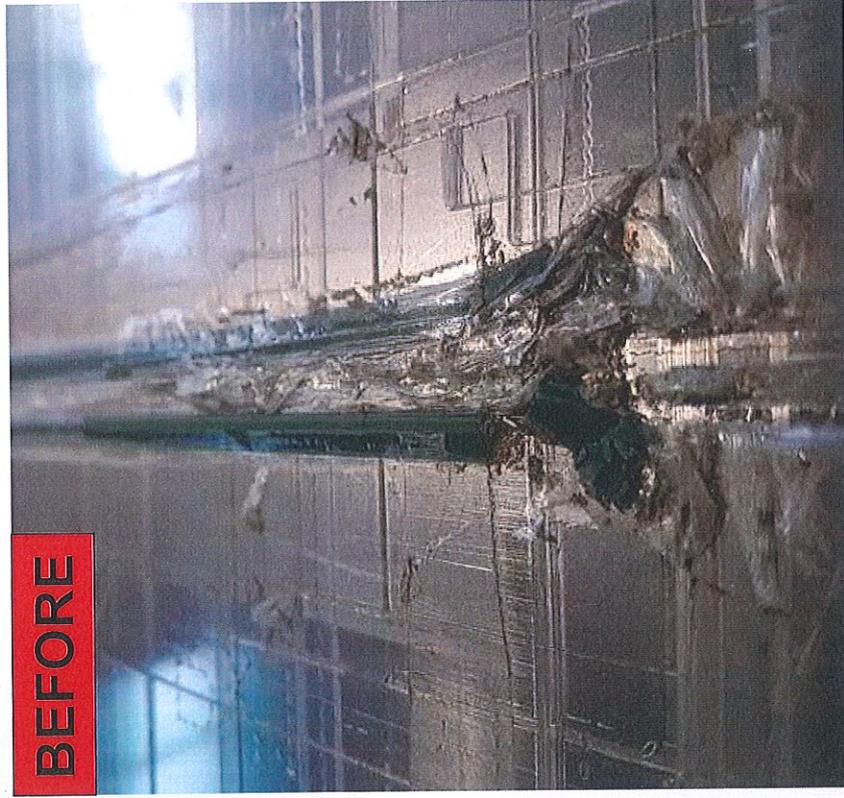
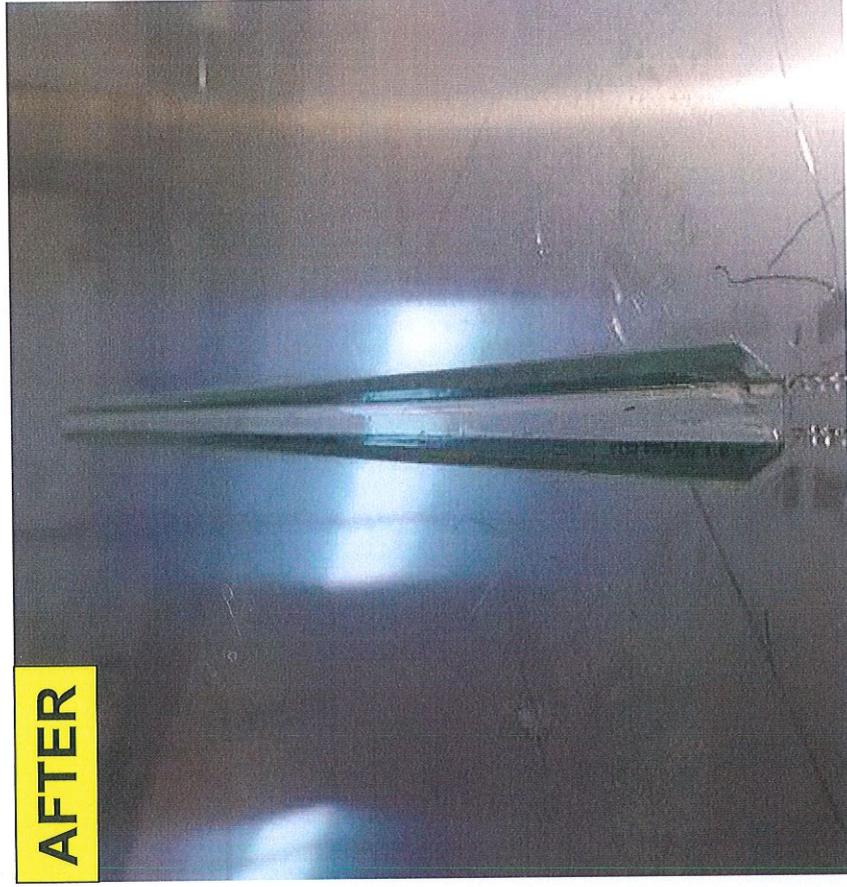
Based on the latest running of the item there is no recorded bursting on the same location.
