KANEPACKAGE PHILIPPINE INC. No. 5 Ring Road LISP II, Brgy. La Mesa, Calamba City, Laguna Telephone No. (049) 545-7166 to 69 Fax No. (049) 545-6302					INVESTIGATION REPORT FORM (IRF) Inhouse Detection Customer Claim Control No.: 438 Date Issued: 21 06 28				
Customer EPSON IJP			Attention To Mr. Gerald De Guzman

INVESTIGATION REPORT FOR BURSTING OF EPSON IJP 5157542-00

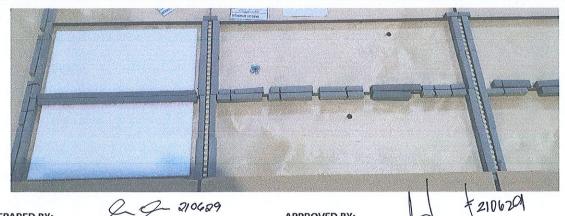
W1 -The brittleness of materials and the ejector sponge in cutting blade is the caused of bursting.				
DIRECT CAUSE PROCESS/MATERIAL	W2- Bursting occurs along the grain direction.				
	W3- During diecut process the ejector sponge in cutting blade causes bursting specially since the cutting blade is along grain direction.

W1-Diecut operator did not notice the bursting during sampling due to random occurrence since this item has 2 outs on the blade.

>Layout Eperan on the affected portion of Epson 515754200
