KANEPACKAGE PHILIPPINE INC.

INVESTIGATION REPORT FORM (IRF)

Customer: NIDEC SUBIC
Item Code: N / A
Item Description: KIVA DUNNAGE BOTTOM
Job Order Number: JO-21-IPD-00611-5B

INVESTIGATION REPORT FOR OFF SPECS OF NIDEC SUBIC DUNNAGE BOTTOM

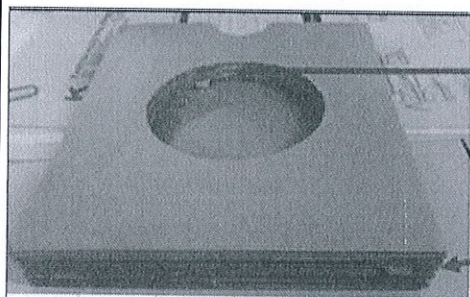
ILLUSTRATION OF THE PROBLEM

3 Layer's

5 layer's

Nature of Defect:

OFF SPECS.

Total number of layers is 6 pcs.; Total number of layers for Part B is 4 pcs.

Total number of layers is 5 pcs.; Total number of layers for Part B is 3 pcs.

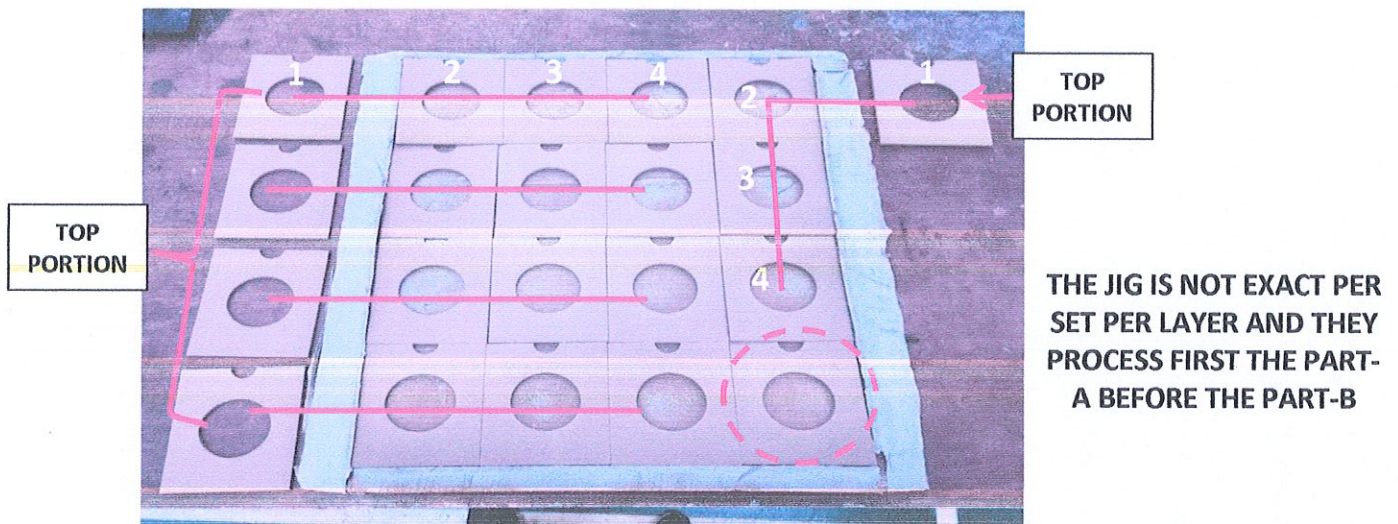
DIRECT CAUSE PROCESS/MATERIAL	W1- There's a factor that the operator mislook the quantity required for Part-B that caused Off Specs.
	W2- Because the jig they used in assembly of dunnage is not exact quantity per set per layer.

INDIRECT CAUSE (OUTFLOW) PROCESS/MATERIAL	W1- Operator did not notice the Off Specs since after curing time they palletized the item for QA Checking.
--	---

1. Make Jig with exact quantity per set per layer for Top & Bottom Dunnage.
2. After Finish the Jig orient the operator for the proper usage of Jig and dispose the existing jig.
