KAN	EPACKAG	E PHILIPPINE INC.	INVESTIGATION REPORT FORM (IRF)					
Telephone	e No. (049) 545-7166 to	a Mesa, Calamba City, Laguna 69	Inhouse Detection	omer Claim				
Fax No. (049) 545-6302		Control No.: 473	Date Issued: 21 10 13				
Customer	KOWA EMOR	1	Attention To	Mr. Gerald De Guzman				
tem Code	HP01D2000		Department	PRODUCTION				
tem Description	CARTON BOX	(Date of Detection 21 10 12					
Job Order Number	JO21-M-01629	9-8	Section Detected QA - SCREENING					
	ILLUSTRATION OF	THE PROBLEM	Major	Mino				
		D2000	Lot Quantity (pcs.)	Reject Quantity (pcs.)	Reject Percentage 1.67%			
			Nature of Defect: DENT					
			Requirement:					
			No dent mark on the surface of the box					
			Actual:		2			
			W/ Dent on the body of the box					
NO. OF OCCU	JRRENCE	DISPOSITION	AREA OF OCCURRENCE / ORIGIN CONTENT					
First		Hold	Slotter Gluing Material					
Recurrence		Special Acceptance	EQOS	Vertical	Dimension

INVESTIGATION REPORT FORM (IRF)

INVESTIGATION REPORT FOR DENT OF KOWA EMORI HP01D2000 CARTON BOX

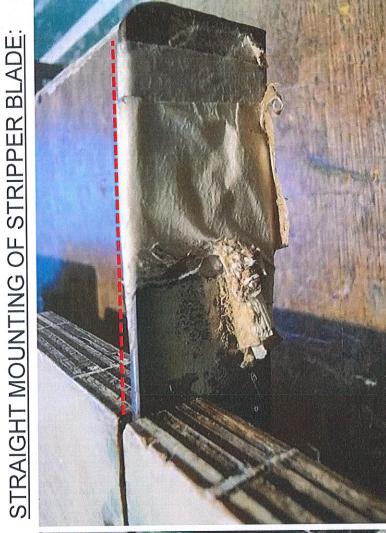
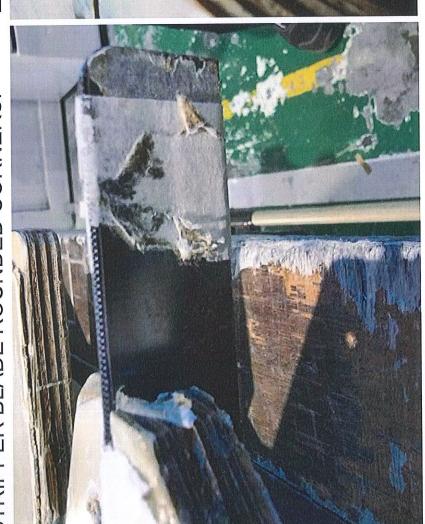
STRIPPER BLADE ROUNDED CORNERS:

DIRECT CAUSE PROCESS/MATERIAL W1- Dent is due to the stripping blade.

W2- Because the edge of stripping blade is pointed and blade is little bit in upward position, when the Printed Board is pulled by gripper it caused dent to the item.

Removed the pointed part of Stripping Blade and make it round curved using Grinder Machine.
