#### KANEPACKAGE PHILIPPINE INC.

### INVESTIGATION REPORT FORM (IRF)

## INVESTIGATION REPORT FOR OFF SHOOT OF EPSON IJP 5162340-00 INDIVIDUAL BOX

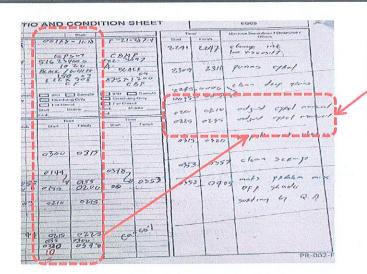
$\mathbf{W1}$ - Upon mass production operator notice the random 2mm movement of print upward in the 2nd unit (black).

W2- This is due to delayed movement of board since the height of board is only 422mm.

**W3**- due to 500mm distance of roller to roller of Eqos, after the next roller grip the 422mm height of board it is already un-grip by 1st roller that caused print movement.

**W1**- Operator did not noticed immediately the Off Shoot since they only conduct sampling checking and when they trap the Off shoot they immediately stop the process and made some adjustment in the cyrel.

OPERATOR MANUALLY ADJUST THE CYREL
UPON DETECTION OF RANDOM
OCCURRENCE OF OFF SHOOT

- \* Adjust the black image cyrel to 2mm downward, so if the delay movement happened due to 422mm height of board it is within the tolerance without Off Shoot. (TD: Done by Operator)
- \* Closely monitor this item next running. (TD: TBA since no open schedule)
