**KANEPACKAGE PHILIPPINE INC.**

INVESTIGATION REPORT FORM (IRF)☒ Inhouse Detection☐ Customer Claim

INVESTIGATION REPORT FOR TEAR OFF OF KOWA-EMORI HP33D1014 CARTON BOX

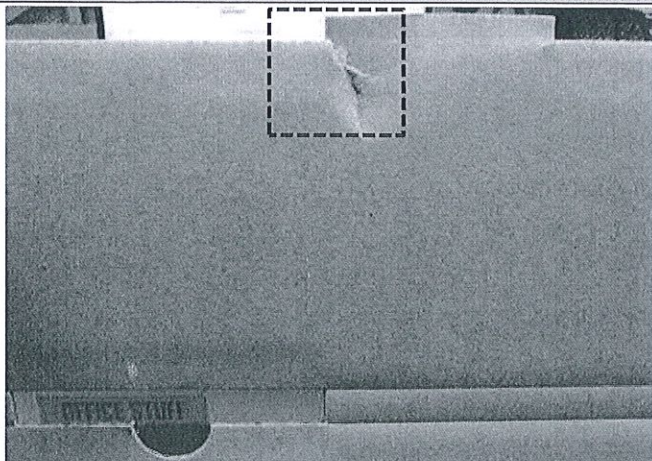
TEAR OFF

Tear off is not acceptable

W/ Tear off

— UNEVEN LENGTH SIZE OF PRINTED BOARD

DIRECT CAUSE PROCESS/MATERIAL	W1- Based on investigation Diecut S1700 encounter uneven length size of printed board.
	W2- Because the item undergo auto stripping, the small size of uneven printed board loosed in auto stripping guide and the right side scrap get small why when the stripping belt collected the scrap it also hit the item that caused Tear Off.

Orient the Diecut S1700 operator to void the stripping process and immediate inform the Leader in-charge once they encounter uneven length size of printed board with auto stripping process.

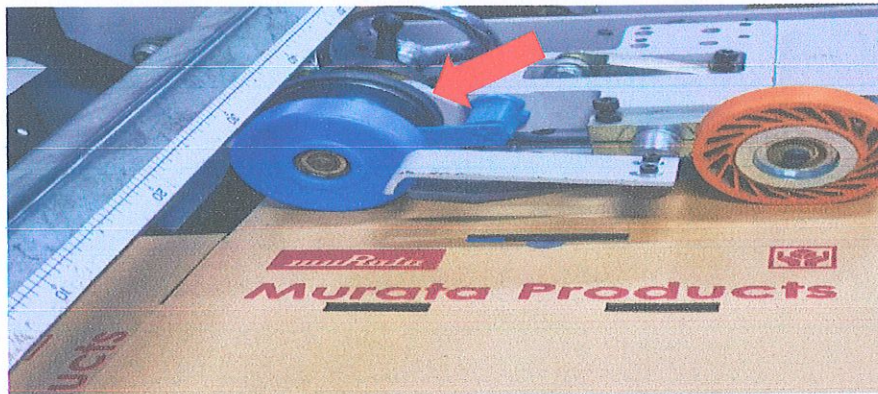
INDIRECT CAUSE (OUTFLOW) PROCESS/MATERIAL	W1- Diecut S1700 operator cant adjust the machine setup because they need to consider the dimension of print.
--	--

- > Void the auto stripping process once they encountered uneven board.
- > Immediately Inform to the Leader in-charge the problem.
- > If the Auto Stripping Process effect to the quality of the item its better to process it to Detaching.
