KANEPACKAGE PHILIPPINE INC. No. 5 Ring Road LISP II, Brgy. La Mesa, Calamba City, Laguna Telephone No. (049) 545-7166 to 69 Fax No. (049) 545-6302		INVESTIGATION REPORT FORM (IRF) Inhouse Detection				
Customer	СВМР	Attention To	Mr. Gerald De Guzman

INVESTIGATION REPORT FOR PEEL OFF OF CBMP FX2-5524-000 Z10 BOX OUTER

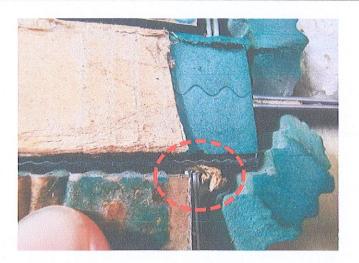
W1- There is a gap from cutting to creasing line blade where the small scrap accumulated during mass production. The accumulated scrap in the gap of cutting and creasing blade effect in the cutting performance of cutting blade and because the item is underwent auto stripping in Diecut S1700 it caused Peel Off to the items.

W2- Possible the gap is due to the hardness of materials (CBF NPK280) and during mass production the small scrap accumulated on that gap.

Repair of Diecut blade c/o Tooling custodian

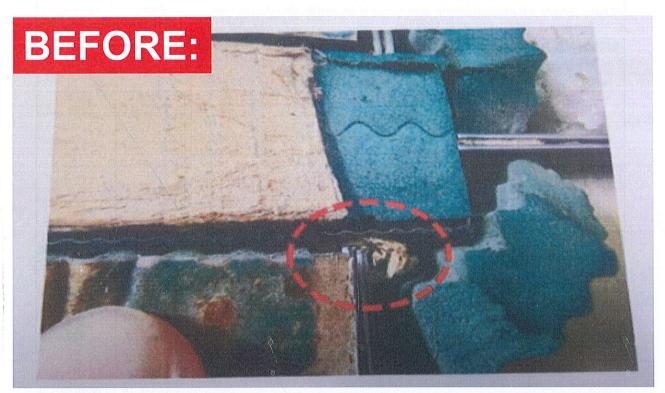
THERE WAS A GAP BETWEEN THE CREASING LINE AND THE CUTTING BLADE.
