INVESTIGATION REPORT FOR GLUE STAIN OF 516230200 LOUVRE 2 MJX EUROPE

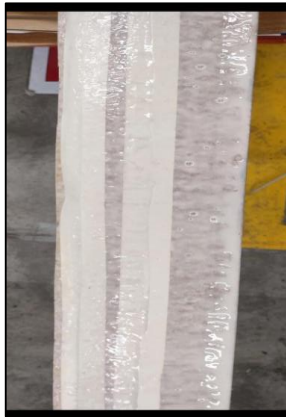
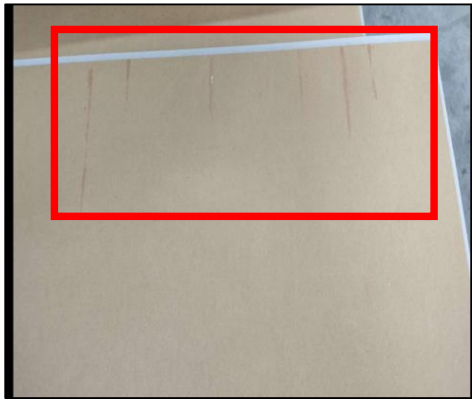
W1: Glue stain occurred due to splashing.

W2: During running the glue was sprinkled in the glue roller to the splashing cover.

W3: The glue viscosity was 2.3 dPa and it was in standard viscosity of 1.8 dPa - 2.5 dPa
>SB with splashing
>SF without splashing
