INVESTIGATION REPORT FOR DELAMINATION OF 516398700, 516228900, 516228200, 515297600, 515821700 LIONEL

DIRECT CAUSE METHOD (MATERIALS)

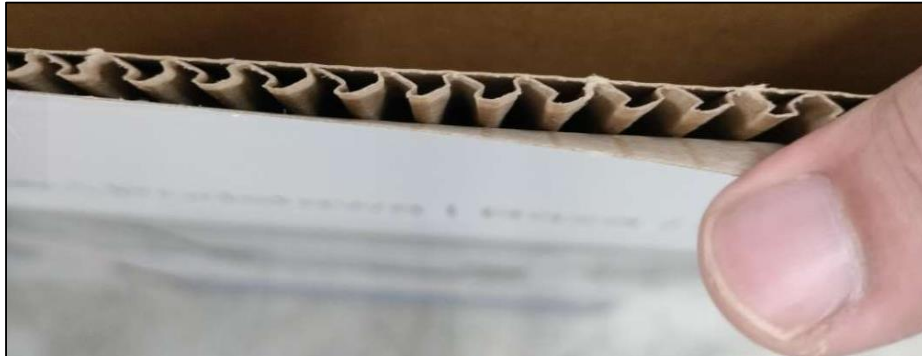
W1: Delamination occurred on the lower flap.

W2: There was an application of glue on panels but it was weak.

- > Glue Viscosity was 2.5
- > Glue App was 4
- > Glue app and viscosity was in standard
