# INVESTIGATION REPORT FOR BURSTING OF RX1-4249-000 CARTON BOX

## DIRECT CAUSE METHOD (PROCESS)

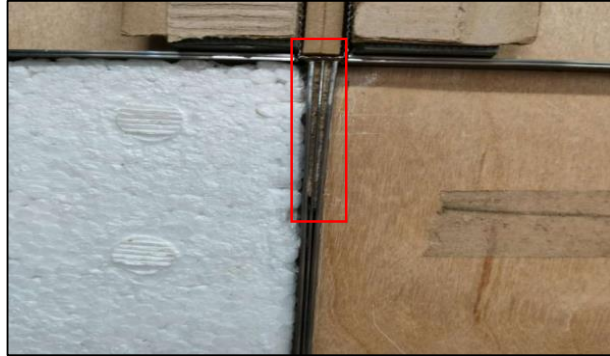
W1: Bursting occurred due to the scrap was left in the creasing blade.

W2: The creasing blade has a gap.

> Immediate action: The blade was pull-out by tooling  
Repair creasing blade

> For PR of blade

> Already PO to purchasing
