INVESTIGATION REPORT FOR MISALIGNED CUT OF 516512900 LIGHT MB US

DIRECT CAUSE METHOD (PROCESS)

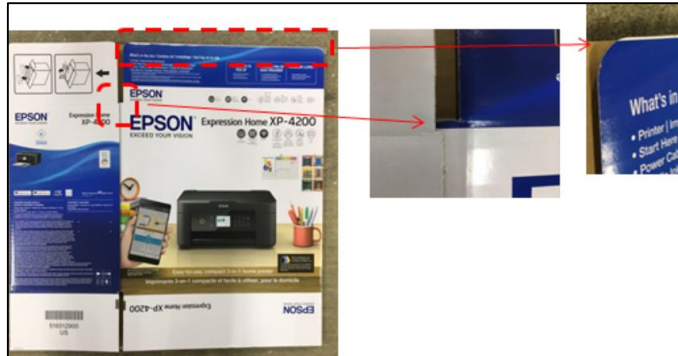
- W1: Misaligned cut occurred due to excess PS and SF.
- W2: Encountered problem in setting-up of side guide on diecut machine.
- W3: The problem were connected in Lamination alignment.

- > To put remarks on JO if left or right alignment
- > Lamination and diecut operators will followed right alignment
- > Meeting with Lamination and Diecut operators
- > Endorsement for night shift.
