INVESTIGATION REPORT FOR MISALIGNED CUT OF 516182300 LINUS FAL ASIA

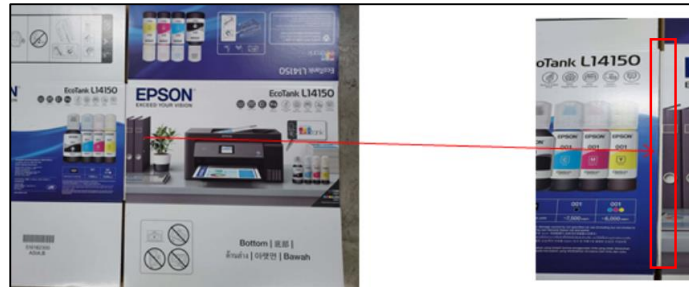
DIRECT CAUSE METHOD (PROCESS)

W1: Misaligned cut occurred due to excess PS and SF.

W2: Encountered problem in setting-up of side guide on diecut machine.

W3: The problem were connected in Lamination alignment.

- > To put remarks on JO if left or right alignment
- > Lamination and diecut operators will followed right alignment
- > Meeting with Lamination and Diecut operators
- > Endorsement for night shift.
