INVESTIGATION REPORT FOR MISALIGNED CUT AT 516041100 LIONELF ASIA

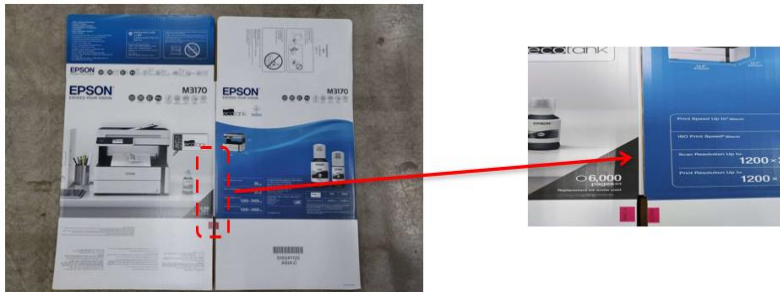
DIRECT CAUSE METHOD (PROCESS)	W1: During process no detection of first out of item, it is possible that the misaligned cut occurred on the folded side of the glue tub portion when the pattern sheet has short bleeding.
INDIRECT CAUSE METHOD (PROCESS)	W1: It is possible to have misaligned cut if the pattern sheet has short bleeding and the machine movement during run was not accurate for the whole run but accept for the limit or tolerance of the movement.

- > Re-orientation to all operator regarding misaligned cut on the folding side of the glue tab portion.
- > improved bleeding for ME
