INVESTIGATION REPORT FOR SCRATCH OF RX1-4516-000 Z10 CARTON - CANON

KANEPACKAGE PHILIPPINE, INC.

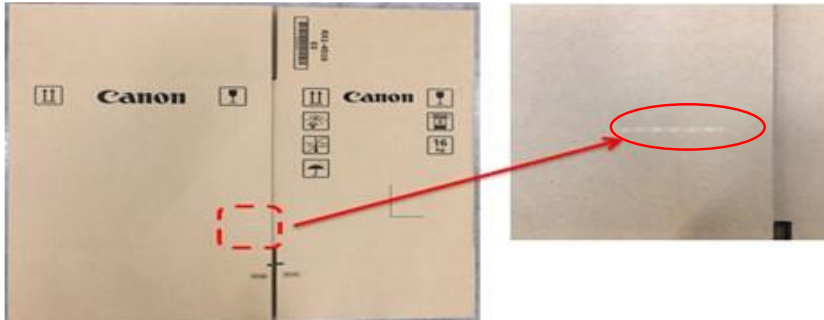
DIRECT CAUSE	W1: The scratches occur when the item passing through conveyor for applying hotmelt glue. Folder
METHOD (PROCESS)	operator detect the scratches.

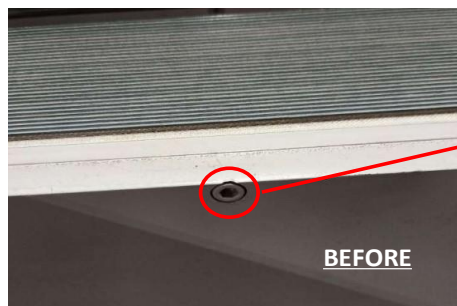
Rough surface

- > Segregation of detected defect and inform inline QA
- > call the attention of PIC/Leader for any abnormality encountered.
- > Inform engineering personel for the repair of the said rough surface at machine
