INVESTIGATION REPORT FOR SAME PAD BLOCK 516443701 PAD ASSY

DIRECT CAUSE METHOD (PROCESS)

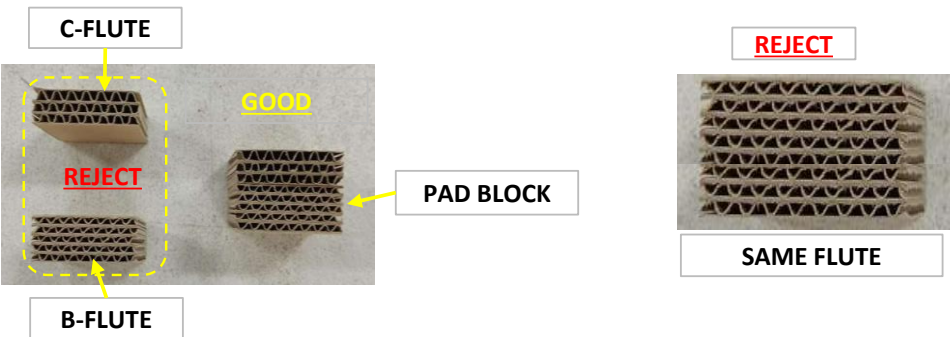
W1: Checking of pad blocks at pad assy, operator check the layer of pad block. 3 layer for C-flute and 5 layer for B-flute.

W2: Same pad blocks may occur when the pad blocks has delam or detached.

W3: Operators do rework for the detached pad block to pad block (same flute), it is possible that they have the same flute attached to each other and operators are not aware for the corrugated of the flute are not the same in appearance and only layer of the flute are their check point.

- > orientation for lucida operators for the issue regarding same pad block for awareness.
- > at lamination they already attached the B-flute and C-flute with printed sheet
