INVESTIGATION REPORT FOR DELAMINATION OF 516513000 LIGHT 2 MB AMERICA

DIRECT CAUSE METHOD (MATERIALS)

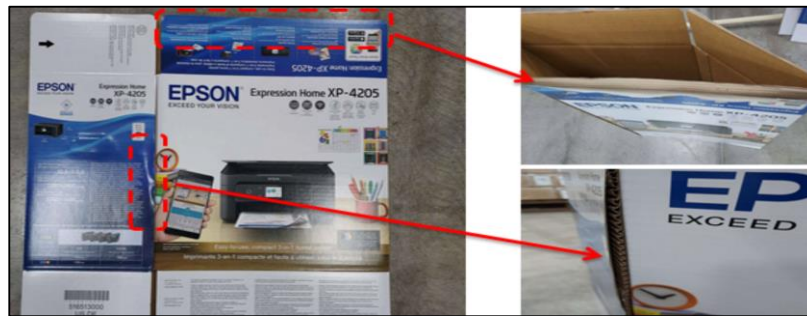
W1: Delamination occurred on the upper flap on the glue tab portion.

W2: But there was an application of glue on the panels.

- > Glue viscosity was 1.9dPa (Standard: 1.8 - 2.5)
- > Glue app was 4mm
- > Mixing of glue: 5mins(powder w/ water),
1min(sodium flakes w/ water) and another 5mins of mixing
- > Conveyor speed was 8 / 70pcs/min
- > There was enough glue in the container

For monitoring of next running for verification.
