## INVESTIGATION REPORT FOR WRONG FLUTE COMBINATION AT PAD ASSY

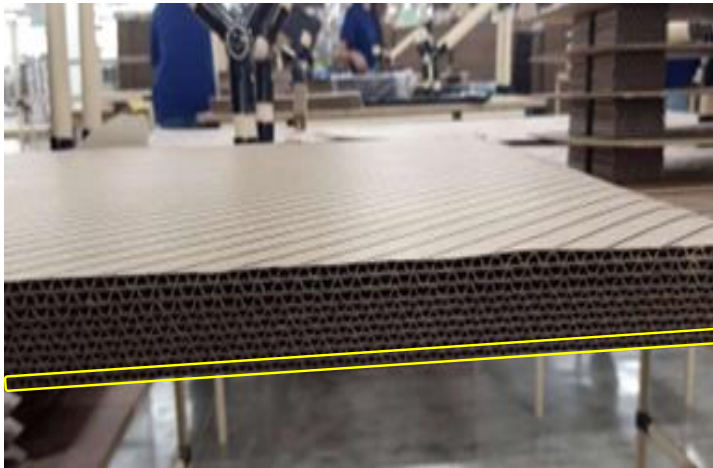
DIRECT CAUSE METHOD (PROCESS)	<p>W1: At lamination process, getting the glued sheet on conveyor then put sheet on table jig one by one (first 5 of B-flute and 3 of C-flute).</p> <p>W2: The excess flute combination is possible to occur at feeder process that may excess the count of B-flute upon entering to feeder. and also when they have trouble on the machine.</p>
INDIRECT CAUSE METHOD (PROCESS)	<p>W2: Using table jig, it is posible that the operator did not notify the qty of flute while processing.</p>

**STANDARD FLUTE QTY.:**

**C-FLUTE: 3**

**B-FLUTE :5**

**ACTUAL**

**B-FLUTE :6**

- > putting marking at table jig
- > re-orient operator regarding issue of wrong flute combination.
