INVESTIGATION REPORT FOR GLUE STAIN OF 515911300 LOUVRE 2 MDX EPIL

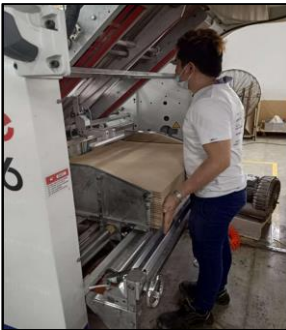
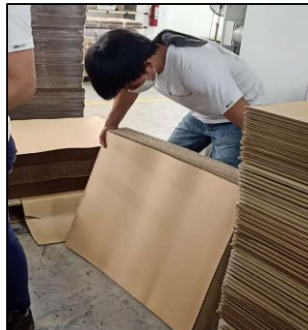
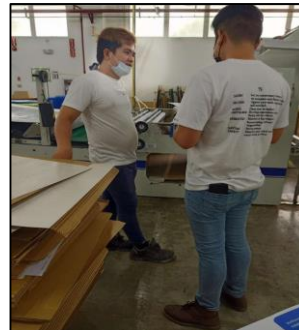
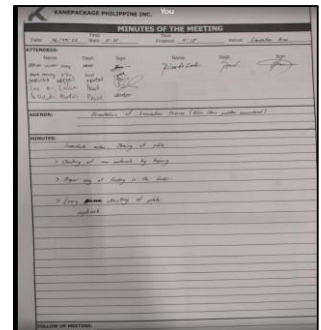
DIRECT CAUSE METHOD (PROCESS)	<p>W1: Glue stain occurred due to foreign material.</p> <p>W2: Foreign material stuck in the glue roller area.</p> <p>W3: Foreign material was in between in the single face.</p>
INDIRECT CAUSE METHOD (PROCESS)	<p>W1: The operator didn't notice the scrap while feeding the single face.</p> <p>W2: Stain occurred during process and the defectiveness from materials are in bulk.</p>

Immediate Action: Cleaning of plate

- > Reorientation to Lamination operators regarding to glue stain encountered
- > Additional checking of raw materials during process
