INVESTIGATION REPORT FOR GLUE STAIN OF 516106600 ROSA SAX INDONESIA

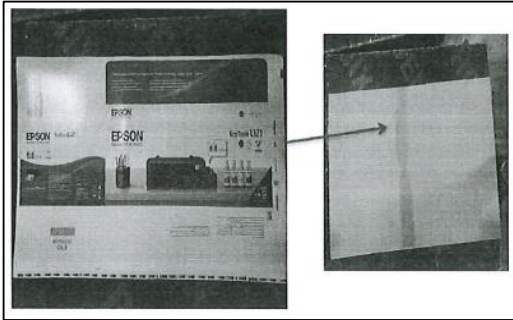
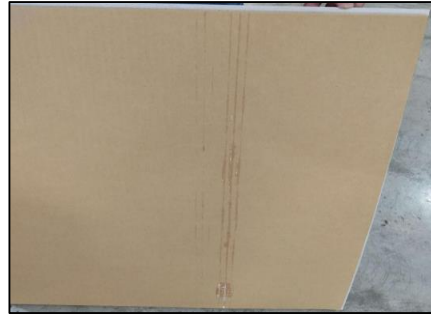
W1: Glue stain occurred on the single face due to foreign material.

W2: Foreign material stuck in the glue roller area.

W3: Foreign material was in between in the single face.

W1: The operator didn't notice the scrap while feeding the single face.

W2: Stain occurred during process and the defectiveness from materials are in bulk.

Immediate Action: Cleaning of glue plate

> Reorientation to Lamination operators regarding to glue stain encountered

> Additional checking of raw materials during process
