**KANEPACKAGE PHILIPPINE INC.**

INVESTIGATION REPORT

1.2. ITEM DESCRIPTION:**PART CODE:** 515138500**PART NAME:** ACCESSORIES BOX**1.3. BACKGROUND:**

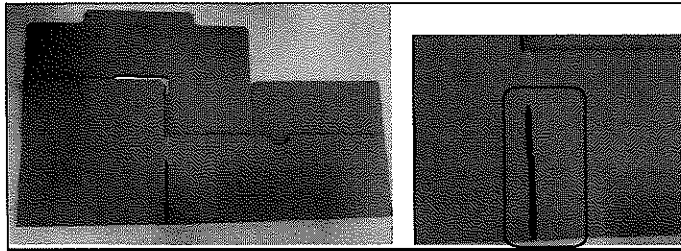
FACTORS	DETAILS
MAN	NO CHANGES
MACHINE	NO CHANGES
METHOD	NO CHANGES
MATERIAL	DEFORMED BLADE OF 515138500
MEASUREMENT	NO CHANGES
ENVIRONMENT	NO CHANGES

UNCUT

> Inhouse Detection : Scratches
> Lot size: 198pcs
> Reject Qty: 59pcs
> Rejection Rate: 29.80%
> JO#: 022910
Remarks: Uncut occurred on the flap side

- WHY 1: Uncut occurred on the flap side of the item.
WHY 2: There is a scrap between the blade that might lead to uncut.
WHY 3: The ejector between the blade has a gap and the scrap was left behind on that gap.
WHY 4: When the scrap was left behind on that gap it creates to deformed the blade.
> The scrap stuck on the ejector.

1. The tooling custodian removed the ejector and closed the narrow gap in the blade and put loctite and changing new ejector.
