KANEPACKAGE PHILIPPINE INC.
No. 5 Ring Road LISP II, Brgy. La Mesa, Calamba City, Laguna
Telephone No. (049) 545-7166 to 69
Fax No. (049) 545-6302

INVESTIGATION REPORT

SCRATCHES

LIONEL MGY

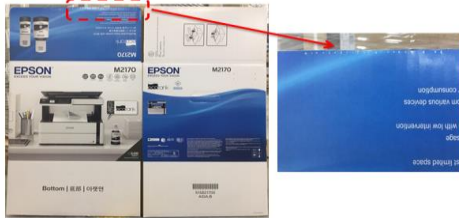
Scratches occurred at upper flap class B (Blue Background) at panel B portion.

WHY 1: Scratches at semi-auto gluing process.

WHY 2: Feeder operator do set-up at the feeding area and the first run of the item are in good condition

WHY 3: During Running of item, they did not notify the panels are having scratches due to feeder guide not in good set-up.

WHY 4: The guide was too close to the item during running and it is possible that when the operator re-feed the feeder area the weight of the item affect while feeding

1. Orient the operator regarding to the issue of scratches for awareness.

- follow the maximum qty of the item at feeder area

- re-setting of feeder guide

-checking of item at catcher/folder for the scratches issue
