**KANEPACKAGE PHILIPPINE INC.**

INVESTIGATION REPORT

514145500

MORESBY OCB

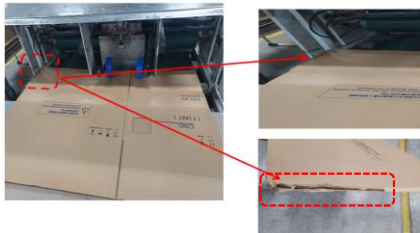
- > Damaged occurred on the bottom flap of the item (see attached photo beside)
- > Lot qty.: 1592ea
- > Good Qty.: 1565 ea
- > Reject qty.: 27 ea
- > Reject Percentage: 1.70%

- WHY 1: DAMAGED OCCUR AT SEMI-AUTO GLUING MACHINE 3
- WHY 2: DURING FOLDING OF ITEM, FOLDER OPERATOR DIDN'T NOTICE THAT THE ITEM WAS HANGING AT THE SIDE PORTION OF THE MACHINE.
- WHY 3: THE ITEM IS TOO WIDE AND WHEN IT ENTERS THE CONVEYOR THE ITEM HAS A LITTLE SPACE AT THE SIDE.

ACTION ITEMS	Target Date:	Person In-charge
Re-orient the operator re regarding to the issue of damaged	221124	IE/SUB-LEADER

- > ORIENT THE OPERATOR REGARDING TO THE ISSUE OF DAMAGED CAUSED BY WIDE ITEM.
