INVESTIGATION REPORT FORM (IRF)

INVESTIGATION REPORT FOR KOWA EMORI HP01D2000-3 CARTON BOX CANNOT FIT LOCK

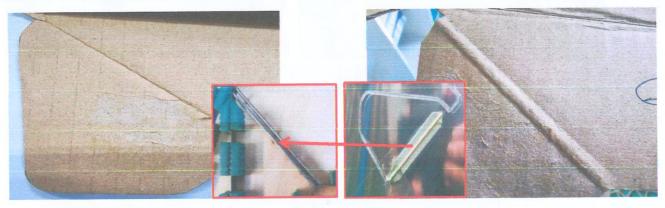
DIRECT CAUSE	1	Upon verification of actual reject it is similar to what happened in Nidec Subic Flexwave D which is due to movement/misalign chase of steel plate.				
	2	July 14, 2022 we coordinate to Engineering the problem and they found out that the height of one of the screw installed in the chase is different of about 8mm that caused inclination of the chase of steel plate and caused misaligned reverse creasing during cutting. As corrective action Engineering pulled-out the chase of steel plate, they remove the screw and grind to reduced the height of screw.				
PROCESS/MATERIAL	- 3	After the repair and finished the Emori D2000, no other item with creasing matrix to be process that day.				
	4	July 15, 2022 night shift they process another batch of Emori D2000 and out of 7500pcs lot quantity there is random of cannot fit lock of 266pcs, there is a factor since the actual reject is similar to Nidec possible that still there is movement happened in chase of steel plate.

REJECT: THE REVERSE CREASING MATRIX IS

GOOD: THE REVERSE CRASING MATIX

> Coordinate to Caledonian the issue regarding chase of steel plate since they have part replacement and preventive maintenance of Eterna on July 27-30, 2022.
