**KANEPACKAGE PHILIPPINE INC.**

**INVESTIGATION REPORT FORM (IRF)**☒ Inhouse Detection☐ Customer Claim

Customer	EPSON ASP/EPLB	Attention To	Gerald De Guzman
Item Code	511600900	Department	Production
Item Description	OUTER CARTON BOX	Date of Detection	22 07 15
Job Order Number	JO22-M-01391-2	Section Detected	QA-SCREENING

## INVESTIGATION REPORT FOR EPSON 511600900 OUTER CARTON BOX POOR SLOT

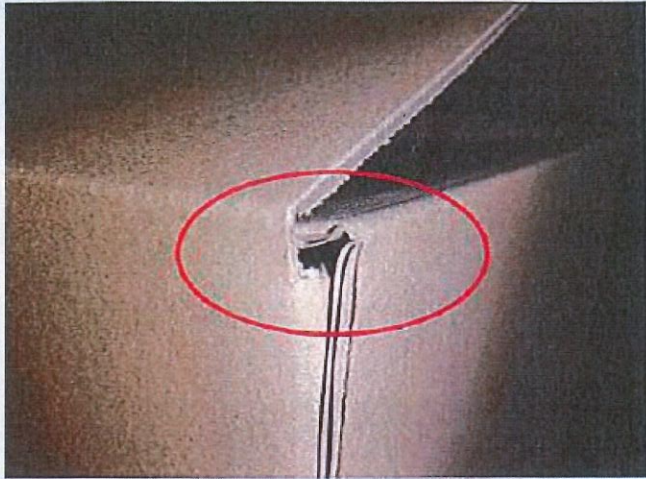
POOR SLOT

No poor slot

poor slot

- ACTUAL BOARD EXCESS BY 6mm  
IN HEIGHT DIMENSION.

1. Orient the Eqos operator regarding this Issue. (TD: 220719)
2. Feed Back to supplier since the raw materials is actual board with creasing and also alert the other concern regarding this issue. (TD: Discuss in 4pm meeting)

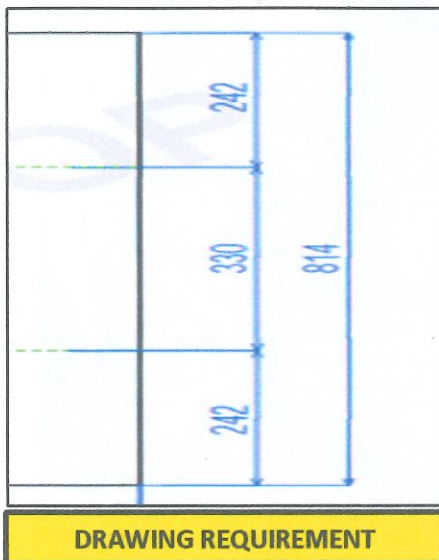
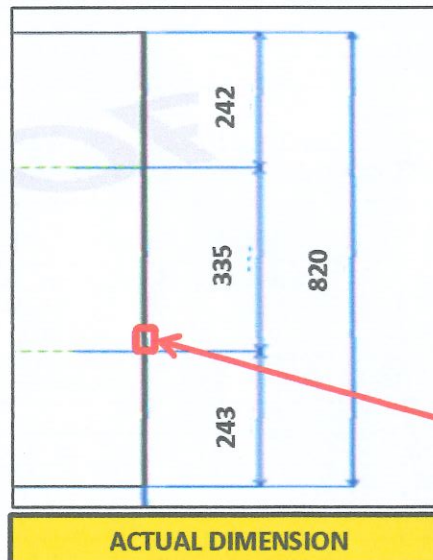
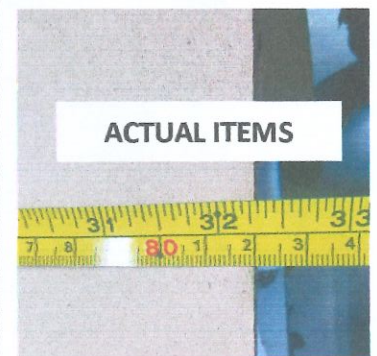
<b>DIRECT CAUSE PROCESS/MATERIAL</b>	<b>W1</b>	Upon checking of actual reject there is 6mm excess in Height dimension of actual items.
	<b>W2</b>	Requirement: 814mm vs. Actual: 820.
	<b>W2</b>	Since the dimension registered in Eqos is based in Drawing dimension the 6mm excess in actual dimension of items result to poor slot.

**6mm POOR  
SLOT OCCURS**

<b>INDIRECT CAUSE (OUTFLOW) PROCESS/MATERIAL</b>	<b>W1</b>	Eqos Feeder didn't notice the uneven sheets since the raw materials pile by 20pcs, possible the first 20pcs pile is correct dimension since out of 260pcs produced by Eqos 240pcs are affected of poor slot.
	<b>W2</b>	Eqos Main Operator didn't notice the poor slot since they don't have enough time to conduct box form checking during sampling since the mass production time is only 3minutes due to machine speed of 105bpm Skip Off mode.
