**KANEPACKAGE PHILIPPINE INC.**

INVESTIGATION REPORT FORM (IRF)☒ Inhouse Detection☐ Customer Claim

Control No.: 603

INVESTIGATION REPORT FOR EPSON 5115938-00 OUTER CARTON BOX BURSTING

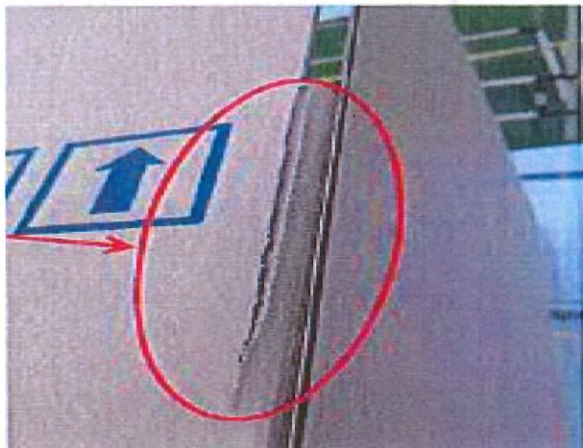
BURSTING

no bursting

occurrence of bursting

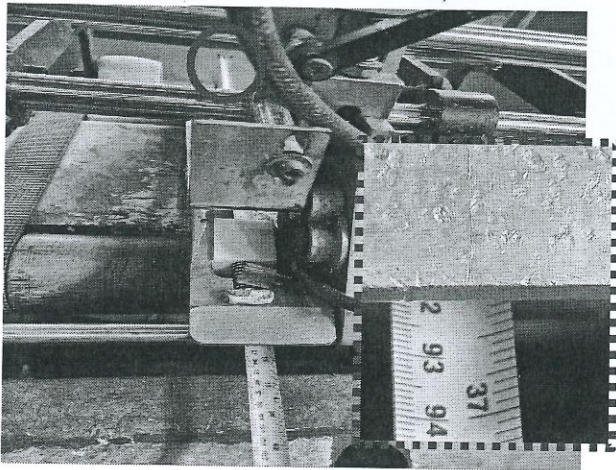
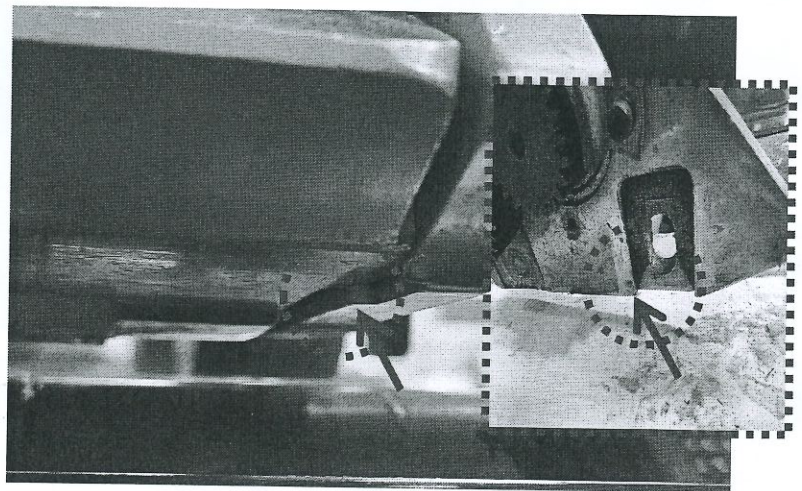
THE POINTED EDGE OF GLUE APPLICATOR
HEAD HOLDER IN SA2600-1 HIT THE ITEMS

Identified Rootcause
Pointed edge of glue tab hit the material

DIRECT CAUSE PROCESS/MATERIAL	W1	There is a pointed edge in glue applicator head holder in SA2600-1.
	W2	Since this item is big box with 939 x 2502 CF when it got incline during feeding in SA2600-1 the pointed edge hit the items result cut/bursting of the items.

Checked by	Date	Implemented?	Remarks
1st Verification of Action	QA IE	7/29/20	<input checked="" type="checkbox"/> Yes <input type="checkbox"/> No	grinded the pointed edge by prd.
2nd Verification of Action			<input type="checkbox"/> Yes <input type="checkbox"/> No	
3rd Verification of Action			<input type="checkbox"/> Yes <input type="checkbox"/> No	
Effectiveness of Action			<input type="checkbox"/> Yes <input type="checkbox"/> No

Request to engineering to grind the pointed age of glue applicator head holder of SA2600-1 and SA2600-2
