**KANEPACKAGE PHILIPPINE INC.**

# INVESTIGATION REPORT

515138500

ACCESSORIES BOX

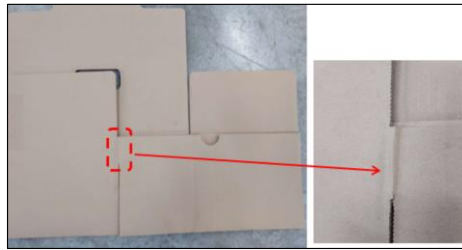
&gt; Inhouse Detection : Worn-Out

Remarks: Worn-out occurred on the folding side

WHY 1: Worn- out occurred on the folding side of the item.

WHY 2: Wrong fold during detaching process.

WHY 3: The operator mistaken folding the item in reversed during process.

&gt; Orientation to the operator regarding for worn out item ( to follow up)

&gt; Set standard detaching of items

&gt; One Point Lesson for detaching process ( to follow up)
