**KANEPACKAGE PHILIPPINE INC.**

INVESTIGATION REPORT FORM (IRF)☒ Inhouse Detection☐ Customer Claim

Customer	EPSON	Attention To	Gerald De Guzman
Item Code	5157542-00	Department	Production
Item Description	INDIVIDUAL BOX	Date of Detection	22 07 12
Job Order Number	JO-DRS22-L-0129-7-11	Section Detected	QA-SCREENING

INVESTIGATION REPORT FOR EPSON 515754200 INDIVIDUAL BOX MISALIGN PRINT

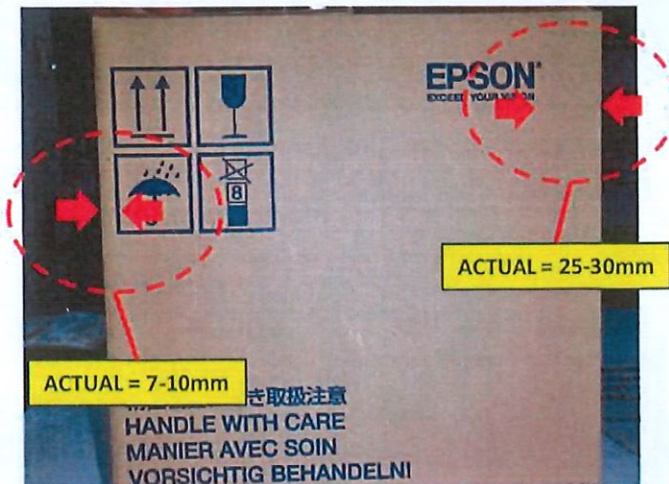
MISALIGN PRINT

20mm +/- 3mm

Print dimension range from minimum of 7mm to a maximum of 30mm

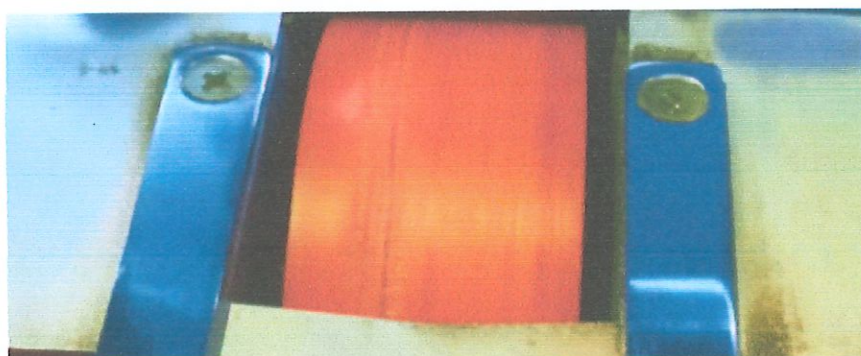
DIRECT CAUSE PROCESS/MATERIAL	W1	The factor consider that caused of misalign print is the blunt orange rubber roller in Eqos feeder. The orange rubber roller in the middle portion get blunt since it always being used due to most of the raw materials run in Eqos range to 600mm-1000mm width.
	W2	Since this item used big sheets with 1010 x 1300mm CF materials, during feeding the board get slipped in orange rubber roller that caused misalign print .

INDIRECT CAUSE (OUTFLOW) PROCESS/MATERIAL	W1	Operator didn't notice the misalign print during sampling since the occurrence are randomly with the machine speed is 110bpm skin on mode.
--	-----------	--

1. Replacement of Orange Rubber Roller (TD: 220717 upon Eqos Maintenance)
2. Set lifespan for Orange Rubber Roller (TD: To be monitor of Production IE's after the replacement)
