**KANEPACKAGE PHILIPPINE INC.**

**INVESTIGATION REPORT**

BURSTING

LIONEL 2 MBL PAD SLEEVE

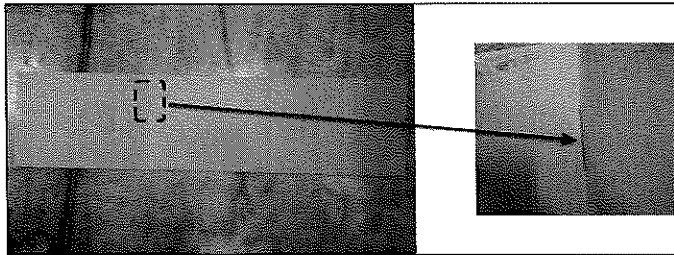
FACTORS	DETAILS
MAN	NO CHANGES
MACHINE	NO CHANGES
METHOD	NO CHANGES
MATERIAL	THERE WAS A SCRAP LEFT ON THE PLATE
MEASUREMENT	NO CHANGES
ENVIRONMENT	NO CHANGES

> Inhouse Detection : Bursting  
> Lot size: 2480pcs  
> Reject Qty: 520pcs  
> Rejection Rate: 20.97%  
> JO#: 022792  
Remarks: Bursting occurred on the creasing

- WHY 1: Bursting occurred on the creasing of the item.  
WHY 2: Due to warp item, there is a possible to cause loose board.  
WHY 3: During running, the loose board of item had stuck on the machine.  
WHY 4: There is a possibility that the item had scrap left behind on the plate.  
WHY 5: The operator didn't notice that there was a scrap on the plate when running.

1. Orientation to the operator regarding the issue of bursting.
2. Removing scrap and cleaning the plate.
3. Always check the machine before, during and after running.
