# INVESTIGATION REPORT FOR DELAMINATION OF PAD BLOCKS

**KANEPACKAGE PHILIPPINE, INC.**

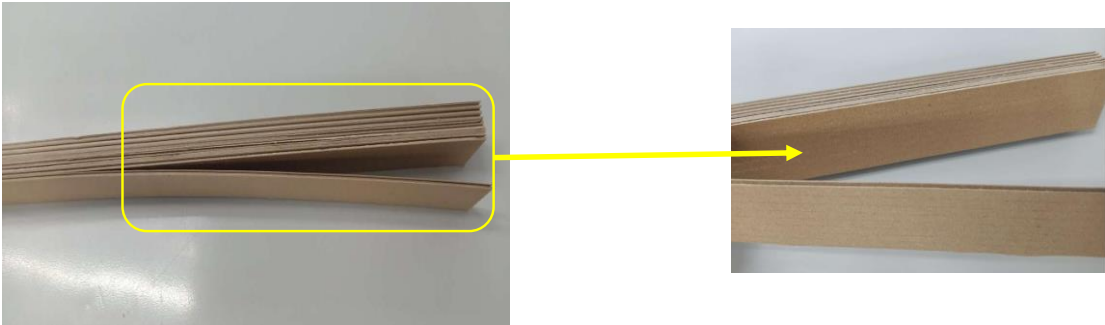
DIRECT CAUSE METHOD (PROCESS)	W1: Vertical operator encounter delamination of Pad blocks during cutting. W2: At lamination process, the glued item must be placing on provided jig one by one (5 for B-flute & 3 for C-flute) W3: The occurrence of having delamination of pad blocks when the item having insufficient application of glue that can cause of detach/delam. W4: It is possible that the the setting of glue application and the speed was change.
----------------------------------	--

- > Rework the item.
- > re-orient operator regarding issue Delamination at pad blocks due to weak glue
