PENDING OPEN ISSUES:

BURSTING

Customer:	EPSON IJP			ILLUSTRATION
Item Description:	516336400 CARTON BOX			
Lot Quantity:	700 PCS.			
Rejected Quantity:	167 PCS.			
Rejection Rate:	23.86 %			
Inspection date:	23 01 13			
Occurrence No.	1 ST	OVERALL:	1ST	
Detected by:	SCREENING QA			
STATUS:	REJECT			
Rejection cost:

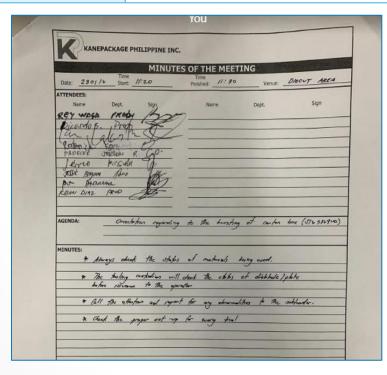
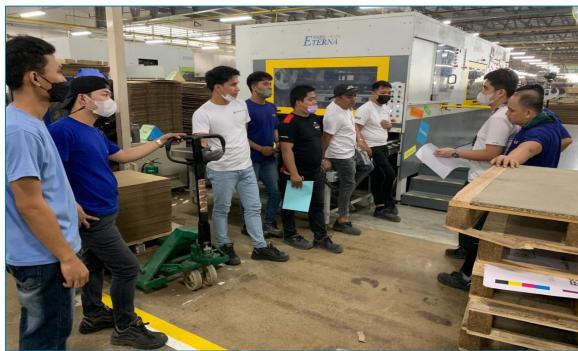
DIRECT CAUSE PROCESS / MATERIAL	WHY 1:	Bursting occurred on the side flap area of the item.
	WHY 2:	Bursting was not notice by the catcher operator during diecut process that cause high rejection of bursting.
	WHY 3:	Sudden movement on the diecut process occurred which possible cause of the bursting encountered. Note: During setting up of the machine, the status of the die blade, creasing matrix, dieplate and pattern sheet were in good condition.
	WHY 4:	Unaligned creasing blade on the creasing matrix during mass production cause the sudden movement.
	WHY 5:	Dieplate might not balance due to untight screw on the diechase.

- > Orientation to the operators regarding to the bursting encountered and proper set-up on machine.
- > Always check the status of materials being use or machine before, during or after running and set-up.
- > The tooling custodian will check the status of dieblade/plate before issuance to the operator.
- > Call the attention and report to the leader/subleader for any abnormalities.
