**KANEPACKAGE PHILIPPINE INC.**

INVESTIGATION REPORT

515912200

LOUVRE 2 MJX

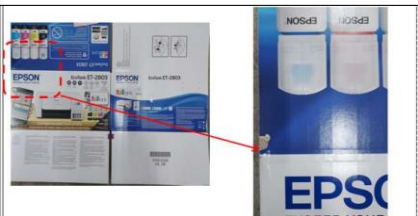
PEEL OFF

- > Inhouse Detection : PEEL OFF
- > Lot size: 1592pcs
- > Reject Qty: 119pcs
- > Rejection Rate: 7.47%
- > JO#: 28795

WHY 1: Peel off occurred on the upper flap class B.

WHY 2: During mass production the operator mislook that the item occurred peel-off.

- > There's a chance that alternating peel-off happen with 5 and 15 rejects out of 20 production.

- > Orientation to the operators regarding to the problem being encountered.
- > Strictly follow start, middle, end, sampling of operator during mass production.
- > Immediate Action: Putting of backing tape and checking of settings.
- > Call the attention of leader/subleader and report any abnormalities.
