**KANEPACKAGE PHILIPPINE INC.**

INVESTIGATION REPORT

05-Jan-23

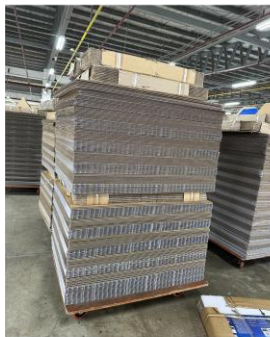
WHY 1: Delamination occurred on Class C Bottom Flap

Why 2 : Improper placement of weights

Why 3: The operators did not follow the standard procedure of weights placement on the top of the item.

Proper way of weights placement

> Orient the operators regarding the issue of Delamination for awareness

> Orient the operators regarding the proper placement of weights on top of the items.
