**KANEPACKAGE PHILIPPINE INC.**

INVESTIGATION REPORT

MISALIGNED CUT

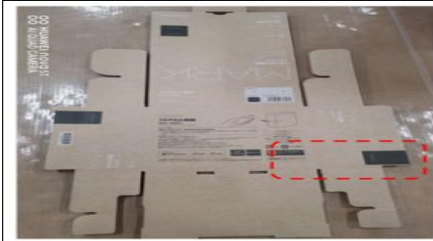
- > Inhouse Detection : Misaligned cut
- > Lot size: 870pcs
- > Reject Qty: 88pcs
- > Rejection Rate: 10.11%
- > JO#: 30257

WHY 1: Misaligned cut encountered with actual measurement of 1mm; Requirement of 5mm.

WHY 2: On trial, there is no misaligned cut encounter but during mass production, the defect comes up.

WHY 3: In the middle of processing, the operator encountered excess single face and printed sheet on the item.

- > Orientation to the operators regarding to the problem being encountered.
- > Immediate Action: The operator sort the items having excess of sf and ps
 - > They adjust the side jucker on the diecut machine to get the exact set-up to prevent the defect.
- > In Lamination process, the catcher operator must inform the subleader/leader if there was an abnormality encountered.
