**KANEPACKAGE PHILIPPINE INC.**

INVESTIGATION REPORT

1.2. ITEM DESCRIPTION:**PART CODE:** 516500500**PART NAME:** LUCIDA MDX CISMEA**1.3. BACKGROUND:****PICTURE**

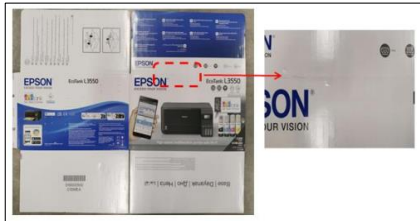
DAMAGED

- > Inhouse Detection : Damaged
- > Lot size: 898pcs
- > Reject Qty: 50pcs
- > Rejection Rate: 5.57%
- > JO#: 30625

- WHY 1: Damaged occurred on the creasing line of the item.
WHY 2: During running the operator(catcher area) noticed that the item in the creasing line was flattened.
WHY 3: The Catcher operator stop the process and check the plate and the creasing matrix was worn out.

- > Orientation to the operators regarding to the problem being encountered.
- > Always check the proper setup of the machine.
- > Immediate Action: Change of creasing matrix by tooling/production.
- > Call the attention and report to the leader/subleader for any abnormalities.
