KANEPACKAGE PHILIPPINE INC. No. 5 Ring Road LISP II, Brgy. La Mesa, Calamba City, Laguna Telephone No. (049) 545-7166 to 69 Fax No. (049) 545-6302	<h1>INVESTIGATION REPORT</h1>					
	Prepared By:	Check By:	Approved By:

1.1. ISSUE:	
	BURSTING
1.2. ITEM DESCRIPTION:	
PART CODE:	516592900
PART NAME:	LOUVRE 2 MJX ICB FOR EUROPE
1.3. BACKGROUND:	
PICTURE

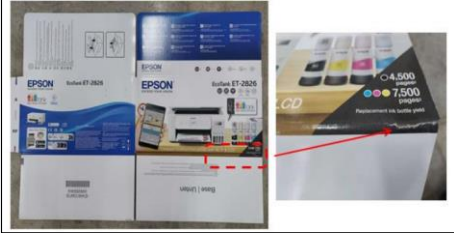
DETAILS: > Inhouse Detection : Bursting > Lot size: 1900pcs (PANEL A) > Reject Qty: 60 pcs (PANEL A) > Rejection Rate: 3.16% > JO#: 32448

WHY 1:	Bursting occurred on the folding side of the bottom part Class A portion of the item.
WHY 2:	During mass production, catcher operator and in-process QA notice occurrence of bursting in the item that was caused by a left-over scrap on the creasing matrix.
WHY 3:	Scrap left on the plate was due to encountered worn out ejector sponge of the blade. Note: That the creasing matrix in the plate was in good condition.
WHY 4:	Worn out ejector sponge was not immediately check which caused to accumulate high rejection of bursting defect.
WHY 5:

1	Conduct an orientation to operators regarding the bursting encountered on Louvre SB. PIC: Prod IE Target Date: 230313	*Please see attached on next sheet*
---	---	--

Changing the ejector sponge from gray to green one since the green ejector sponge was harder than the gray ejector sponge.
PIC: Tooling Custodian
Target Date: 230310

Checking the condition of creasing matrix before setting up of the machine.
PIC: Prod. In-charge
Target Date: 230313
