KANEPACKAGE PHILIPPINE INC. No. 5 Ring Road LISP II, Brgy. La Mesa, Calamba City, Laguna Telephone No. (049) 545-7166 to 69 Fax No. (049) 545-6302	<h1>INVESTIGATION REPORT</h1>		
	Prepared By:	Check By:	Approved By:
	K.DIAZ	N. CEPEDA	R. MIRANDA
DATE:	21-Mar-23	QA-IE/ Prodn IE	QA/ Prodn SV
		KPLIMA Operations Gen. Mngr.

1.1. ISSUE:	
	PEEL-OFF
1.2. ITEM DESCRIPTION:	
PART CODE:	516513000
PART NAME:	LIGHT MB ICB FOR AMERICA DE
1.3. BACKGROUND:	
PICTURE

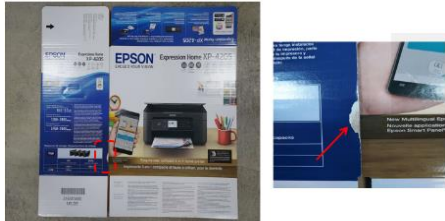
DETAILS: > Inhouse Detection : PEEL OFF > Lot size: 1600pcs > Reject Qty: 47pcs > Rejection Rate: 2.94% > JO#: 33046

WHY 1:	Peel off was due to manual stripping process in which the edge part of the board/ panel was been detached.
WHY 2:	Detached edge part was due to encountered uncut during running in the diecut process.
WHY 3:	Uncut was encountered randomly and alternating in which from every 20 pcs output, 5 pcs found out to have uncut issue. Note: During mass production, the catcher mislook the occurrence of uncut.
WHY 4:	Uncut was due to imbalance condition of the blade. Note: The item used new blade and new pattern sheet.

ACTION ITEMS	Target Date:	Person In-charge
Production gluing in-charge inform the diecut subleader regarding the occurrence of peel off defect.	230320	Gluing subleader and Diecut subleader

1	Checking and repair of the blade. PIC: Tooling custodian Target Date: Checking of the next running of the item	*Still for monitoring*
2	Orientation regarding the checkpoints of the diecut catcher operator. Remarks: Uncut must be rework immediately by in-charge once observed. PIC: Production IE Target Date: March 23, 2023	*Please see attached on next sheet*
