KANEPACKAGE PHILIPPINE INC. No. 5 Ring Road LISP II, Brgy. La Mesa, Calamba City, Laguna Telephone No. (049) 545-7166 to 69 Fax No. (049) 545-6302	<h1>INVESTIGATION REPORT</h1>		
	Prepared By:	Check By:	Approved By:
	GIELEN SAYAS	NOEMI CEPEDA	RHODORA MIRANDA
DATE:	23-Mar-23	QA-IE/ Prodn IE	QA/ Prodn SV
		KPLIMA Operations Gen. Mngr.

1.1. ISSUE:	
	DELAMINATION
1.2. ITEM DESCRIPTION:	
PART CODE:	516106500/ 515912200
PART NAME:	ROSA SAX ASIA/ LOUVRE 2 MJX EAI
1.3. BACKGROUND:	
PICTURE

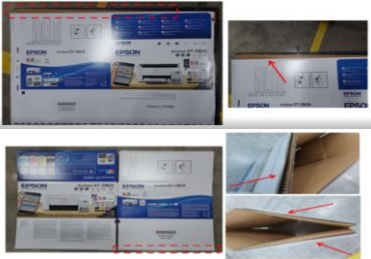
DETAILS: ROSA SAX LOT QTY: 398 REJECT QTY :23 REJECT PERCENTAGE: 5.78% DETAILS: LOUVRE 2 MJX EAI LOT QTY: 794 REJECT QTY :100 REJECT PERCENTAGE: 12.59%

WHY 1:	DELAMINATION OCCURRED ON THE UPPER AND BOTTOM FLAP
WHY 2:	GLUE VISCOSITY WAS 2 FOR ROSA SAX AND 2.1 FOR LOUVRE 2 (STANDARD 1.8-2.5) GLUE APPLICATION WAS 4 IMPRESSION 22mm (RUNNING WATER 5mm) CONVEYOR SPEED 8
WHY 3:	GLUE APPLICATION WAS 4 IMPRESSION 22mm (RUNNING WATER 5mm) CONVEYOR SPEED 8
WHY 4:	THERE ARE CERTAIN PARTS OF THE SINGLE FACE USED THAT ARE WARP AND SLIGHTLY PRESSED/ FLAT
WHY 5:	DURING MASS PRODUCTION, THE OPERATOR DID NOT NOTICE THAT THE QUALITY OF SOME SINGLE FACE ARE NOT GOOD OR DID NOT MET THE QUALITY STANDARD.

1	The process should be put on hold while the quality assurance team verifies the raw materials. If the QA team determines that the items met the requirements, they should make a note or sign for the approval of the items. This is especially important if the operators notice any single faces that are not good, did not meet the quality standard, or had any abnormalities encountered on the raw materials (including warpage and flattened or pressed single faces).	*Please see attached on next sheet*
---	---	--
