KANEPACKAGE PHILIPPINE INC. No. 5 Ring Road LISP II, Brgy. La Mesa, Calamba City, Laguna Telephone No. (049) 545-7166 to 69 Fax No. (049) 545-6302	<h1>INVESTIGATION REPORT</h1>		
	Prepared By:	Check By:	Approved By:
	K.DIAZ	N. CEPEDA	R. MIRANDA
DATE:	March 28-2023	QA-IE/ Prodn IE	QA/ Prodn SV
		KPLIMA Operations Gen. Mngr.

1.1. ISSUE:	
	Damage
1.2. ITEM DESCRIPTION:	
PART CODE:	516297800
PART NAME:	LOUVRE 2MDX, ASIA W;C
1.3. BACKGROUND:	
PICTURE

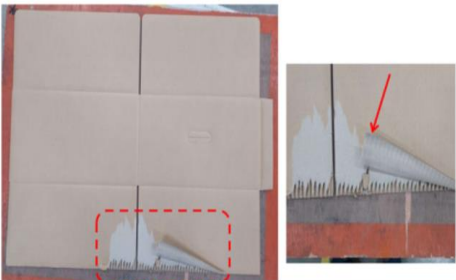
DETAILS: >Inhouse Detection : Damage >Lot size: 798pcs > Reject Qty: 15pcs >Rejection Rate: 1.88% >JO#: 33373

WHY 1:	During mass production, hand rod was not tight which caused damaged in the bottom flap of ICB. Note: Total quantity running was 798 pcs. and been detected in the middle of running wherein adjustments in the front guide hook was done.
WHY 2:	Loose hand rod was mislook by the operator in-charge and while placing the panel on the feeder section, the panel hits on the bottom feeder while running.
WHY 3	The placement of panel in the bottom feeder was improperly done. Note: The placement of panel in the bottom feeder not match the angle of the feeder section causing damaged.
WHY 4:	Operator in-charge was not following the standard machine start-up and set-up prior mass production.

Orientation and reminder regarding the implementation and correct and proper machine set-up.
PIC: Production IE and Sub-leader in-charge
Target Date: March 28, 2023

Generate OPL as eyemark for the implementation of monitoring and checking every run the hand rod and front guide hook.
PIC: Die Cut Feeder Operator
Target Date: April 3, 2023
