**KANEPACKAGE PHILIPPINE INC.**

INVESTIGATION REPORT

BURSTING

LOUVRE 2MCX ASIA/LOUVRE 2MJX EAL (SF)

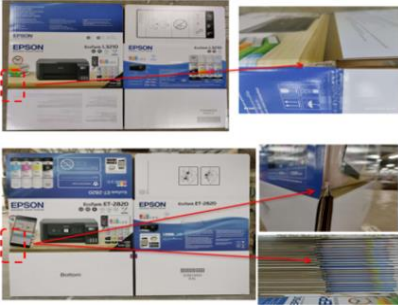
> Inhouse Detection : BURSTING
> Lot size: 1077pcs
> Reject Qty: 67pcs
> Rejection Rate: 6.22%
> JO#: 33375/33383

WHY 1:	Bursting happens since the creasing blade is higher than the cutting blade while its running.
WHY 2:	Due to the cushion crease's weakening and decreased ability to adhere to the board, the sheet board fails to fold correctly, resulting in bursting while its running.
WHY 3:	Applying too much backing tape and not aligning with the standard adhesive backing tape line. Note: During mass production, the operator applies backing tape where the tape expands or bulges due to over-application that cause bursting
WHY 4:	The die plate had a slope shape that was not compatible in die chase where bursting occurred. Note: During the machine set up, the operator did not notice that the die plate was sloped and was no longer compatible with the die chase.

1	Checking and repair of the blade and Die palte Remarks: Sharpen the blade and trimming die plate if its needed. PIC: Tooling custodian Target Date: March 28, 2023	*Still for monitoring*
---	---	-------------------------------
