**KANEPACKAGE PHILIPPINE INC.**

INVESTIGATION REPORT

DOUBLE PANEL

LOUVRE 2 MJX ICB FOR EUROPE D

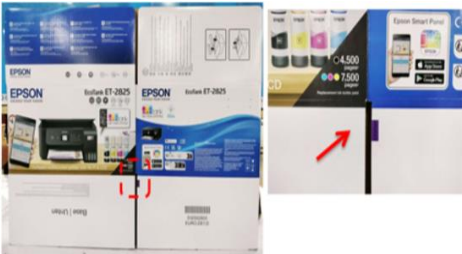
- > Inhouse Detection : DOUBLE PANEL (BOTH PANEL A)
- > Lot size: 298 ea
- > Reject Qty: 1 ea
- > Rejection Rate: 0.34%
- > JO#:

WHY 1:	Double panel were due to feeding of same panel A during process at gluing machine 3.
WHY 2:	During process of panels, folder operator failed to check the difference between panel A and Panel B. Note: The item has a destination code as POKAYOKE marking.
WHY 3:	Folder Operator was not totally familiar to its check points on the process.
WHY 4:	Folder operator was new on the process. Note: The folder operator was still under training and evaluation. (cross trainee)

ACTION ITEMS	Target Date:	Person In-charge
Pull out the folder in-charge and undergone reorientation.	April 5, 2023	Gluing subleader/Senior Operator

1	Orientation was conducted to operator in-charge to discuss the critical checkpoints on semi-auto gluing process. PIC: Production IE In-charge Target Date: April 11, 2023	
---	---	--
