<div style="display: flex; align-items: center;"> <div> KANEPACKAGE PHILIPPINE INC. No. 5 Ring Road LISP II, Brgy. La Mesa, Calamba City, Laguna Telephone No. (049) 545-7166 to 69 Fax No. (049) 545-6302 </div> </div>	INVESTIGATION REPORT			
	Prepared By:	Check By:	Approved By:	
	MHVITO	N. CEPEDA	R. MIRANDA	
DATE:	230505	QA-IE/ Prodn IE	QA/ Prodn SV	KPLIMA Operations Gen. Mngr.

I. PROBLEM DESCRIPTION

1.1. ISSUE:	
	Double Pannel
1.2. ITEM DESCRIPTION:	
PART CODE:	515998000
PART NAME:	LIONEL PG MGL ICB FOR AMERICA
1.3. BACKGROUND:	
PICTURE

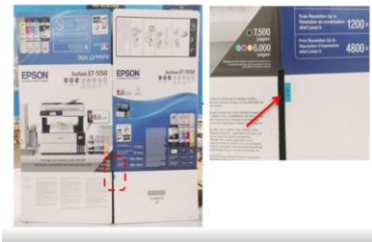
DETAILS: > DOUBLE PANEL -DOUBLE PANEL OCCURED ON THE ITEM (SAME PANEL B) -LOT QTY: 99 -REJECT QTY: 1 -REJECT PERCENTAGE:1.01%

WHY 1:	DOUBLE PANEL OCCURRED ON THE ITEM (SAME PANEL B) DURING MANUAL GLUING PROCESS
WHY 2:	WHILE EXECUTING A MANUAL GLUING, OPERATORS CHECK BOTH PANELS AND THEY DID NOT ENCOUNTER SAME PANEL DURING THE PROCESS. NOTE: IT'S POSSIBLE THAT WHILE DOING THE MANUAL GLUING, SOME OTHER PANEL WAS MIXED UP UPON THE PROCESS.
WHY 3	CHECKING THE QUANTITY OF BOTH PANELS IF THEY WERE EVEN (PANEL A AND PANEL B) BEFORE FOLDING IT WAS MISSED BY THE OPERATOR IN-CHARGE.
WHY 4:	OPERATOR FAILED TO DO MANUAL BROWSING BEFORE START RUNNING.
WHY 5:	THERE IS NO STANDARD WORK INSTRUCTION FOR MANUAL GLUING. NOTE: ONLY SEMI-AUTO GLUING AND MANUAL GLUING FOR EMORI ITEMS WAS USED AS TEMPORARY WI.

ORIENT THE OPERATOR REGARDING TO THE ISSUE OF DOUBLE PANEL AND REMIND THE OPERATORS TO ALWAYS CONFIRM THAT BOTH PANELS ARE ACCURATE BEFORE BEGINNING THE FOLDING PROCESS.

REVISION OF WI TO INCLUDE MANUAL GLUING
