KANEPACKAGE PHILIPPINE INC. No. 5 Ring Road LISP II, Brgy. La Mesa, Calamba City, Laguna Telephone No. (049) 545-7166 to 69 Fax No. (049) 545-6302	INVESTIGATION REPORT		
	Prepared By:	Check By:	Approved By:
	K.DIAZ QA-IE/ Prodn IE	N. CEPEDA QA/ Prodn SV	R. MIRANDA KPLIMA Operations Gen. Mngr.
DATE:	MAY 18, 2023

1.1. ISSUE:	
	Damage
1.2. ITEM DESCRIPTION:	
PART CODE:	516512700/51651300
PART NAME:	LIGHT 2 FA America/Light 2 MB America
1.3. BACKGROUND:	
PICTURE

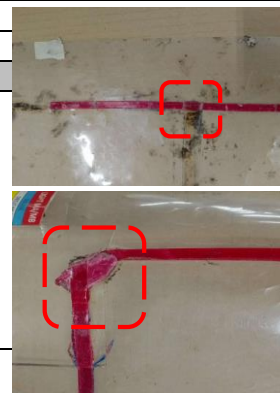
DETAILS: >Inhouse Detection :DAMAGE >Lot size: 2072 > Reject Qty: 48pcs >Rejection Rate: 2.32% >JO#: 36242/36243

WHY 1:	Damaged encountered on the diecut- inline detaching process in which the edge part of board/panel was improperly teared.
WHY 2:	Improper teared causing damaged of the board/panel was due to encountered uncut.
WHY 3:	Uncut was due to encountered widen of the backing tape during running in mass production. Note: The pattern sheet was also observed to be almost worn out.
WHY 4:	Proper use of backing tape was not properly followed.

1	Replacement of pattern sheet for Light MA and FA.	PIC: Tooling Custodian and Subleader Target Date: May 19, 2023
2	Orientation to diecut operator regarding the encountered damaged due to uncut and proper use of backing tape and proper disposal of pattern sheet that was worn out.	PIC: Production IE Target Date: May 19, 2023
3	To have a monitoring to have a pattern sheet lifespan. Note: This is still under observation if needed and could be feasible.	PIC: Production IE Target Date: June, 2023
4	Generate an OPL (One Point Lesson) as an eyemark for the diecut operators regarding proper use of backing tape and pattern sheet as well.	PIC: Production IE Target Date: May 24, 2023
