**KANEPACKAGE PHILIPPINE INC.**

**INVESTIGATION REPORT**

MISALIGNED CUT

**1.2. ITEM DESCRIPTION:****PART CODE:** 516446102 / 516445502**PART NAME:** PAD BASE**1.3. BACKGROUND:****PICTURE**

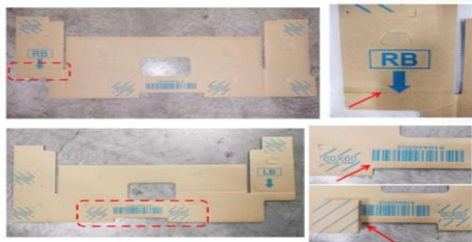
> Inhouse Detection : MISALIGNED CUT  
> Lot size: 6783pcs  
> Reject Qty: 1229pcs  
> Rejection Rate: 18.12%  
> JO#: 36209 / 36271 / 36362

<b>WHY 1:</b>	Misalign cut occurred when the feeder side move during Mass production. Note: During set up and trial that released 1 pc for production sample and 10 pcs for QA sample that result good quality, while proceeding with mass production, the operator did not notice the feeder side moved which resulted in a misaligned cut.
<b>WHY 2:</b>	The operator is not aware that the feeder side has moved. Note: The operator base on the first set up is ok, and the operator is not expected that there will be an adjustment in the feeder side guide where the misalign cut appears
<b>WHY 3:</b>	Due to the feeder side mismatch, it resulted misalign cut while running. Note: In 3 J.O found 1229 rejects out of 6783 pcs of item

1	Follow the standard number of item in the feeder section (Only put 1pc) Remarks: During Set up and Trial	PIC: Operator Target Date: May 15, 2023
2	Reorient the operators regarding to the procedure manual of the machine operation process.	PIC: Production IE Target Date: May 15, 2023
