<div style="display: flex; align-items: center;"> <div> KANEPACKAGE PHILIPPINE INC. No. 5 Ring Road LISP II, Brgy. La Mesa, Calamba City, Laguna Telephone No. (049) 545-7166 to 69 Fax No. (049) 545-6302 </div> </div>	INVESTIGATION REPORT		
	Prepared By:	Check By:	Approved By:
	K.N. ACUIN	N. CEPEDA	R. MIRANDA
DATE: 230522	QA-IE/ Prodn IE	QA/ Prodn SV	KPLIMA Operations Gen. Mngr.

1.1. ISSUE:	
	WORN-OUT
1.2. ITEM DESCRIPTION:	
PART CODE:	515048700
PART NAME:	CARTON BOX
1.3. BACKGROUND:

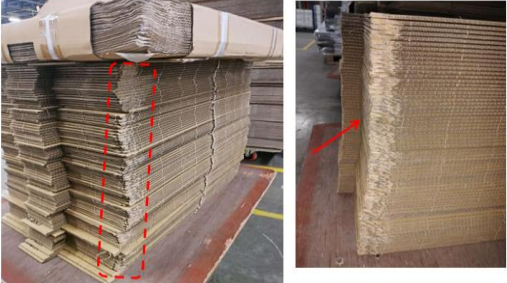
DETAILS: <div style="margin-left: 20px;"> > WORNOUT ON THE EDGE OF THE ITEM > REJECT QTY. 72 PCS >LOY QTY. 240 PCS > MAJOR REJECT /DETECTED BY QA </div>

WHY 1:	THE ITEM CODE 515048700 SUDDENLY FALL DOWN DURING MANUAL DETACHING
WHY 2:	WHILE THE OPERATOR IS MANUALLY DETACHING THE ITEM, HE IS IN BENDING POSITION (NAKAYUKO) AND HE DETACH THE SCRAP SO FAST SO HE DIDN'T NOTICED THAT THE ITEMS ARE WIGGLING

1	FROM 250 PCS OF ITEMS FOR EVERY CASTER PALLET DECREASE THE NUMBER OF ITEM DEPENDING ON THE HEIGHT OF THE OPERATOR (EXAMPLE IF THE OPERATOR HEIGHT IS 5'0 THE NUMBER OF ITEM SHOULD BE 200 PCS)	230515
---	--	--------
