KANEPACKAGE PHILIPPINE INC.

INVESTIGATION REPORT

CRACKING

PART NAME: LINUS FAL AMERICA

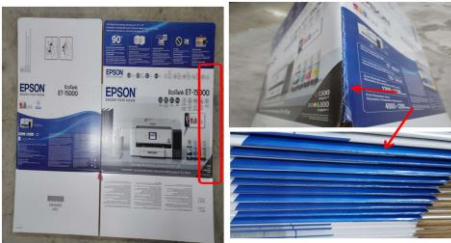
PICTURE

- > Inhouse Detection : CRACKING
- > Lot size: 498 pcs
- > Reject Qty: 64 pcs
- > Rejection Rate: 12.85%
- > JO#: 37614

WHY 1:	CRACKING OCCUR AT DIE-CUT MACHINE FOR THE ITEM 516181800 LINUS FAL AMERICA
WHY 2:	WHEN THE OPERATOR FOLDS THE ITEM, A CRACK IS FOUND IN THE SEMI AUTO GLUING PROCESS, AND THE ITEM HAS A CRACK ON THE FOLDING SIDE.
WHY 3:	CRACKING OCCURS DUE TO THE SET UP (PLATE AND PATTERN SHEET) THEY USED, THE OPERATOR DID NOT START FROM THE BEGINNING OF MACHINE SETTING (BACK TO ZERO) WHEN THEY PUT THE NEW STEEL PLATE IN THE DIE-CUT, AND STILL THEY USED AN OLD PATTERN SHEET.
WHY 4:	THE OPERATORS KNOW THAT WHEN THE BLADE IS NEW AND THE PATTERN SHEET IS ALSO NEW, THEY SHOULD ALSO GET A NEW PATTERN SHEET AND START FROM THE BEGINNING OF SET UP, BUT THEY ARE UNAWARE OF THE PROCEDURE FOR WHEN THE PLATE IS NEW, THEY SHOULD ALSO GET A NEW PATTERN SHEET AND START FROM THE BEGINNING OF SET UP (BACK TO ZERO).

ACTION ITEMS	Target Date:	Person In-charge
TOOLING REPLACE A NEW PATTERN SHEET NAD STEEL PLATE FOR LINUS	230613	TOOLING

1	RE- ORIENT THE DIE- CUT OPERATOR REGARDING THE CRACKING ENCOUNTERED AND THE PROPER PROCEDURE IN SETTING UP THE MACHINE.	
2	WHETHER THE PLATE OR BLADE IS NEW AUTOMATICALLY THE PATTERN SHEET SHOULD ALSO NEW OR IF THEY USED A GOOD CONDITION PATTERN SHEET OPERATOR MUST REMOVE THE BACKING TAPE IN THE PATTERN SHEET AND REPLACE A NEW ONE. MOREOVER, OPERATOR MUST SET UP THE MACHINE FROM THE BEGINNING (BACK TO ZERO SET UP).	
3	POSTING A REMINDER IN THE DIE CUT AREA REGARDING USING NEW PLATE / NEW BLADE AND INCLUDING IT IN THE WORK INSTRUCTION.
