INVESTIGATION REPORT

NO INSERT PAD ITEM CODE 516378900 LIME 2 MB ICB FOR AMERICA

Item Code : 516378900

Item Description : LIME 2 MB ICB FOR AMERICA

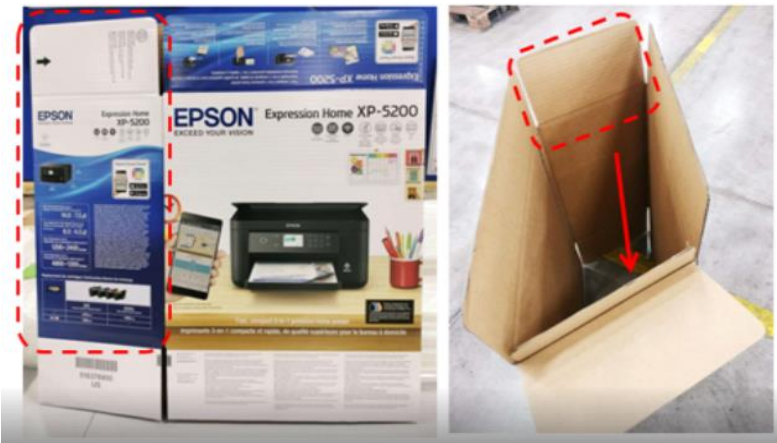
Why 1: PROBLEM OF MISSING INSERT PAD ON ITEM 516378900 (LIME 2 MB ICB FOR AMERICA) DURING MANUAL GLUING PROCESS.

Why 2: OPERATOR MANUAL GLUING MISSED LOOK OF ATTACHING OF INSERT PAD ON THE ITEM.

Why 3: PANELS & INSERT WAS NOT PROPERLY SEGREGATED DURING THEIR MANUAL GLUING PROCESS.

Why 4: NO CONTROLS OF PANELS QTY VS INSERT PAD DURING MANUAL PROCESS THAT MAY HELP NOTICE BY OPERATOR EITHER LACKING OR OVER PICK-UP OF ITEMS.

Why 5: CONTROLS NOT INCLUDED IN STANDARD

SORTED ALL AFFECTED QUANTITY TO AVOID FLOW-OUT TO CUSTOMER.

REMIND OPERATORS TO INCLUDE THE CHECKING OF INSERT PAD OF THOSE ITEM W/ INSERT PAD REQUIREMENT.

1. REVISION OF WI OF MANUAL INSERT PAD PROCESS TO INCLUDE THE CONTROLSQUANTITY OF PANELS INSERT.
ex. 10 PANELS VS. 10 INSERT PAD IN THE TABLE.
2. MONIFICATION OF MANUAL GLUING TABLE TO PROVIDE SPACE FOR INSERT PAD, PANELS & GLUING PAN.
3. ORIENTATION OF REVISE STANDARD TO ALL GLUING OPERATORS TO AVOID THE REOCCURENCE OF PROBLEM.
