INVESTIGATION REPORT

SCRATCHES AND GLUE STAIN ENCOUNTERED IN ITEM CODE 516512800 (LIGHT FA EUROPE R;B)

Item Code :516512800

Item Description : LIGHT FA EUROPE R;B

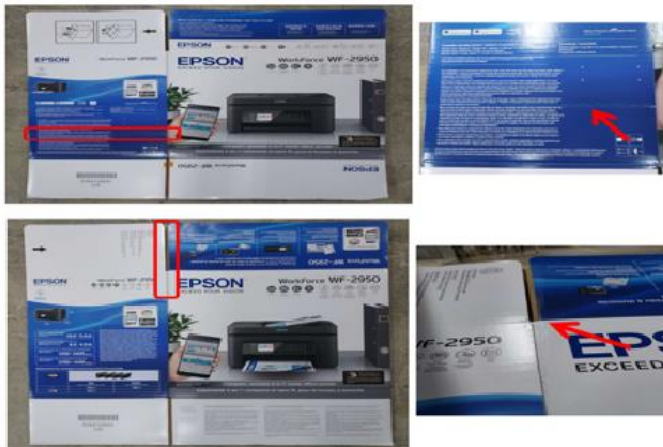
Why 1: SCRATCHES ENCOUNTERED IN ITEM CODE 516512800 (LIGHT FA EUROPE R;B)
DURING MASS PRODUCTION IN SEMI AUTO GLUING 3

Why 2: DOUBLE FEEDING OCCURRED BECAUSE OF THE FLATTENED UPPER FLAPS OF THE OTHER PANELS THAT
TEND TO STOP THE ROLLER DUE TO DIFFERENT HEIGHT OF PANELS AND MACHINE ROLLER THAT ALSO
CONTRIBUTE OR FACTOR OF SCRATCHES PROBLEM

Why 3: BECAUSE ONCE THE FIRST FEED PANEL STUCK ON THE WEIGHTS ROLLER THE NEXT PANEL WILL MOVE THE FIRST
PANEL GOING TO THE WEIGHT ROLLER WHILE TO CONTINUES TO ROLL & CREATE SCRATCHES ON THE ITEM (FIRST FEEDED
ITEM)

MANUAL FEEDING

RECONDITIONING THE ITEMS

RE-EDUCATE THE OPERATOR REGARDING THE ISSUE
